Two Estates Project

Clackmannanshire Field Studies Society

Alloa Estate Project

The Alloa Pond

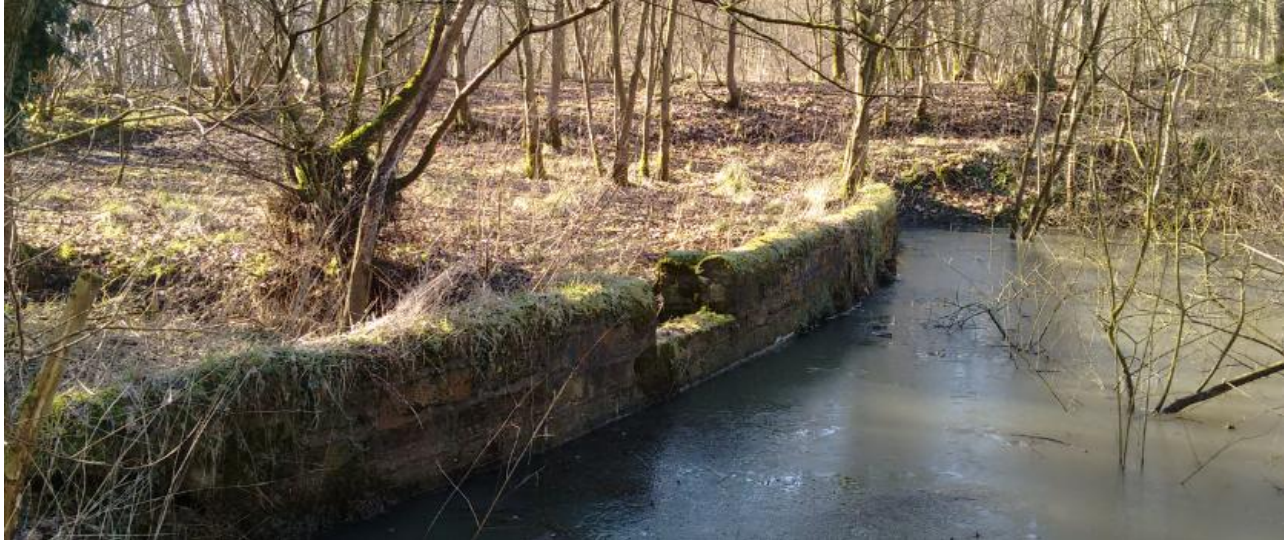
Figure 15. Dam well filled by runoff from urban drainage.

The increased depth of water in the pond had led to an increased pressure at the outlet at the base of the dam and the flow of water through the outlet channel was greatly increased. It appeared that there was some mechanism which controlled the flow of water out of the dam and that it was partly open or leaking.

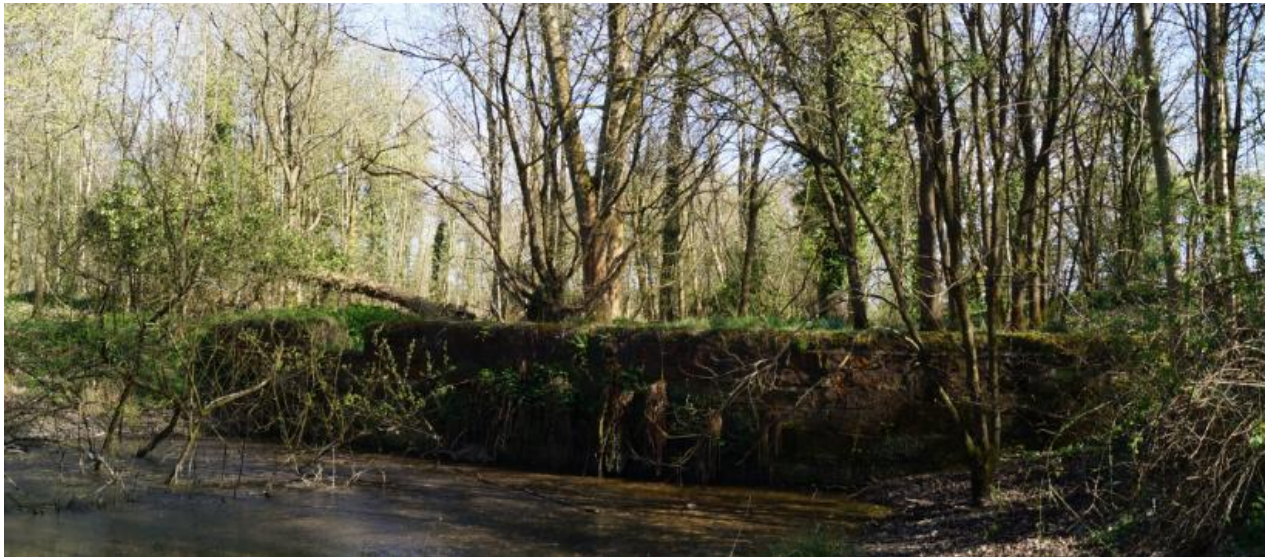
Figure 19. Sandstone facing to the earthen dam.

This facing wall is built in the shape of an arch, with its apex pointing towards the pond. This structure both protects and adds strength to the earthen dam

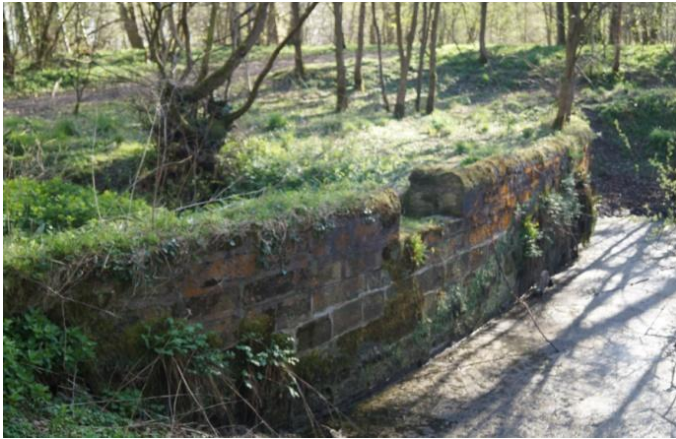
Figure 20. Arch shaped facing and overflow.

There were several different types of joint mortar, suggesting that the wall had been repaired on a number of occasions. An overflow has been built into the southern end.

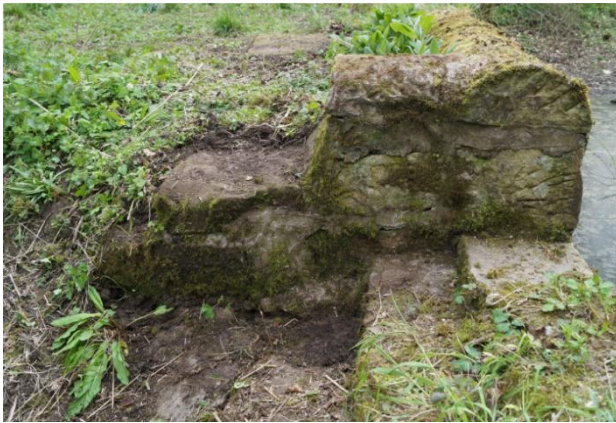
Figure 28. Three steps of the overflow.

The overflow shows signs of repair with several different types of cement-based mortar used. The concrete slipway has been broken in half and here are signs of water having removed earth from underneath and around it.

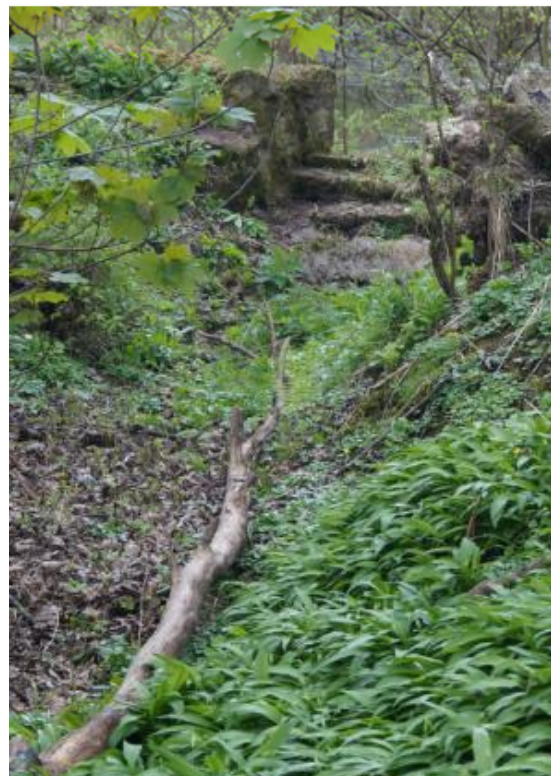
Figure 29. The overflow ditch.

The overflow leads into a ditch cut into the earthen apron in front of the dam and leads to the North bank of the river Black Devon. The ditch has been filled in in two places to allow the path around the pond and the path along the bank of the river Black Devon to cross it and now cannot act as a drainage channel for the overflow.

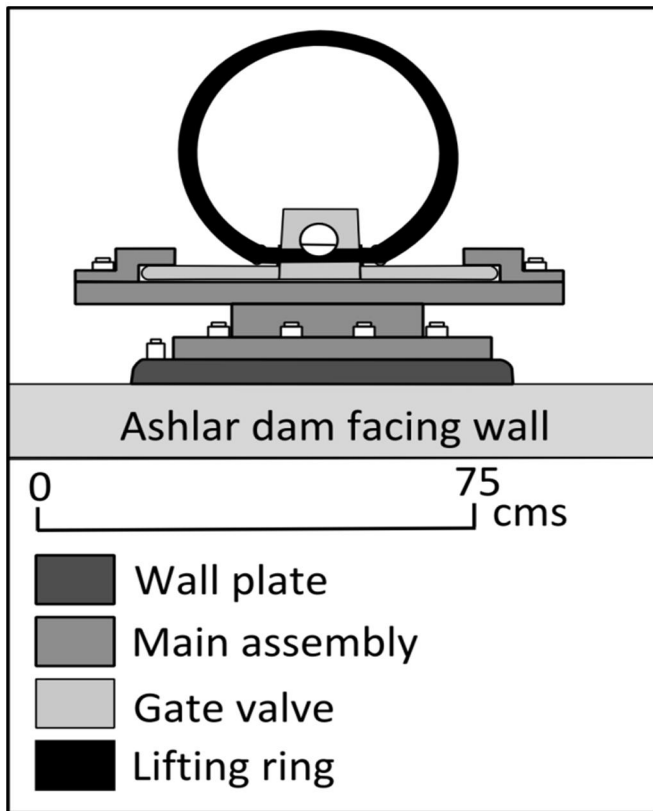
Figure 37. Sluice from above.

From all our observations, a rectangular metal plate is set into the facing wall of the pond dam. This is secured with cement and a small number of bolts. A main circular fitting with a short length of pipe links to a front rectangular section. This main cast assembly is bolted on to the plate. The front section has two slides bolted on to the vertical edges. A metal sluice valve with a ring fitting sits within the two slides. The large ring is attached to a small, extension casting on the sluice valve, possibly with a metal collar. There are two small bulbs where the ring has been welded to fit into the collar. The ring allows the gate valve to be easily accessed under several metres of water.

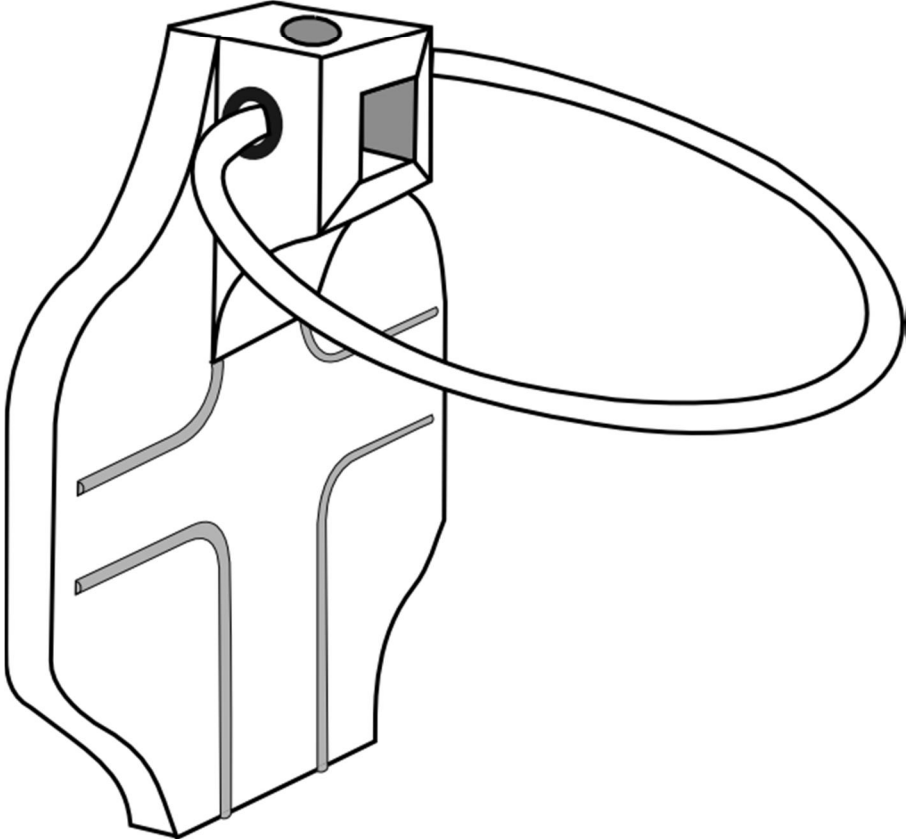
Figure 39. Side view of gate valve.

The main vertical assembly has a cast ridge across the bottom, upon which the gate valve sits. The gate valve has a pattern of cast ridges on the front. The horizontal ridges end just short of the vertical slides. This would have kept the gate valve centred in the slides, with the minimum amount of friction. The gate valve is shaped to have only a small portion of its sides within the slides, again reducing the friction when it is moved. From the position of the gate valve, it is clear that the valve is sitting in the closed position. This raises questions as to the source of water flowing out of the dam drain.

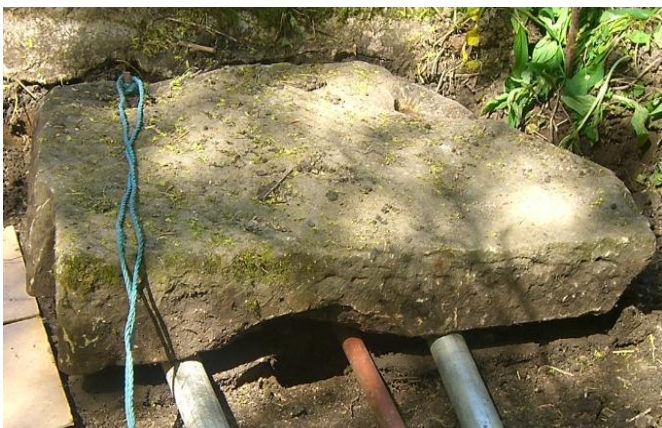
Figure 42. The access slab removed.

The pit was sounded to a depth of 89 inches (2.26 m). There was standing water in a cavity at the bottom and what looked like the remains of a metal bar or rod. The slab was carefully replaced and the earth back filled

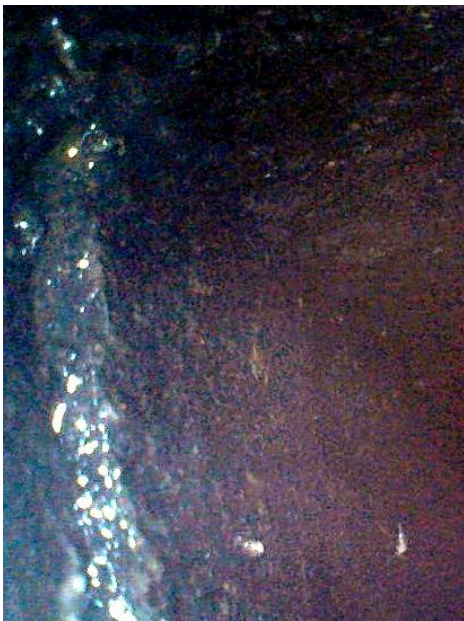
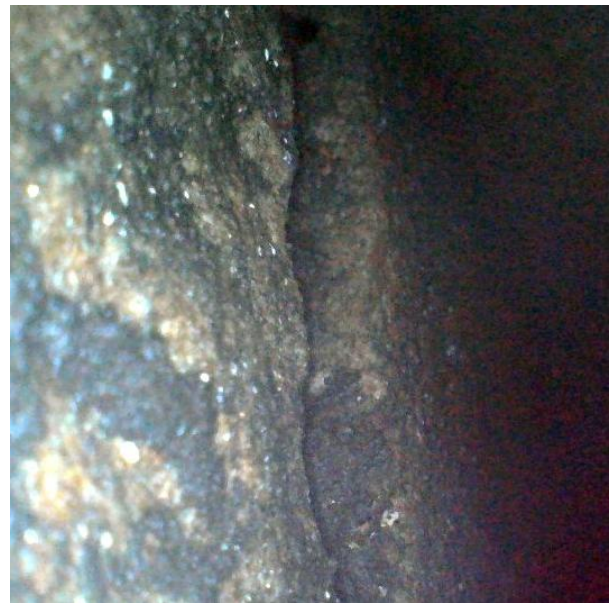
Figure 46. Leak in access pit.

More than halfway down the pit there was evidence of water leaking in from the earth dam.

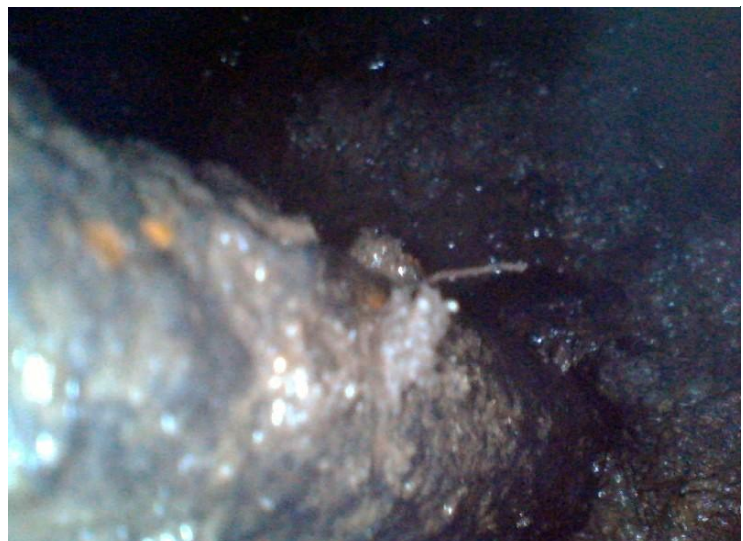
Figure 47. Metal rod in the base of the access pit.

Although badly corroded, the remains of the vertical metal rod which had been noted in the bottom of the access pit are fairly clear. It would appear that it was, at one time, of a square cross section.

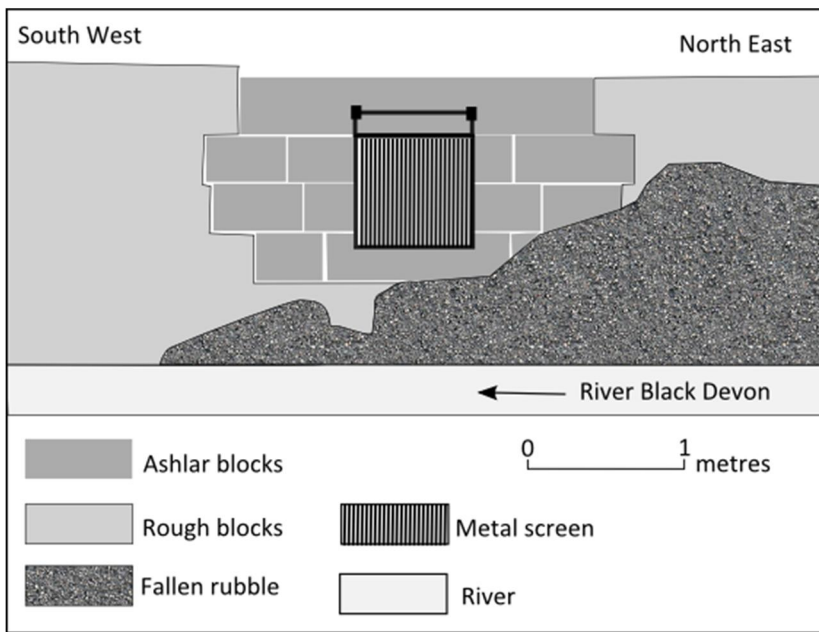
Figure 55. Elevation of inlet sluice.

A hinged, metal screen has been set into the river side top block. The screen opens outwards towards the river Black Devon. A considerable quantity of fallen rubble lies in the river alongside the walls, suggesting that they were higher in the past. The rubble is a mixture of well-cut ashlar blocks from the inlet sluice and more roughly formed blocks from the older wall.

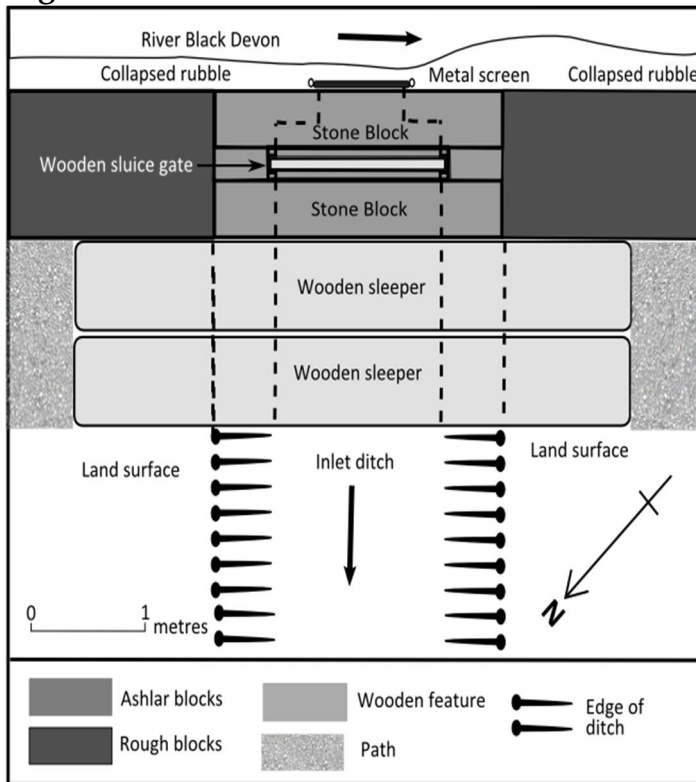
Figure 57. Plan of inlet sluice.

Two wooden sleepers have been laid across the landward side of the sluice to enable the river side path to be carried across the inlet ditch. The fact that water ran out of the inlet sluice during the period of high water level which filled the pond showed that the base of the inlet ditch was lower than the top of the overflow in the pond dam.

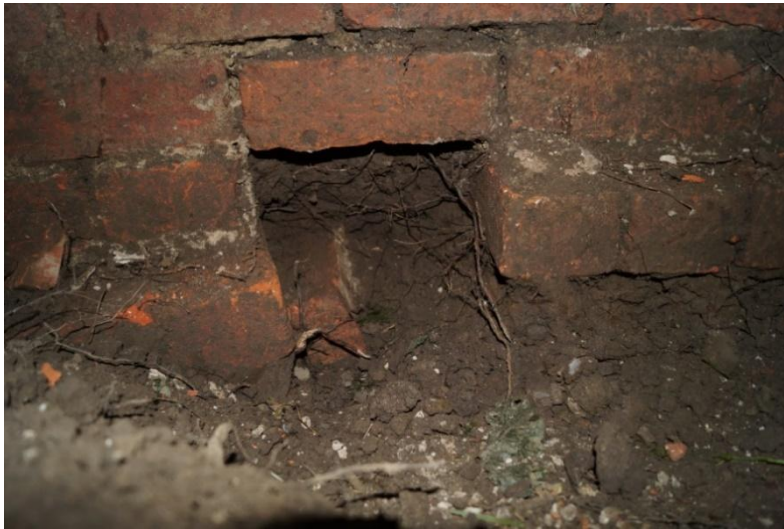
Figure 96. Ice house wall with stepped foundation.

This photograph shows the base layer of bricks stepping down from right to left. There was a gap at the junction, filled with a slump of white sandstone. The existence of a layer of mortar on the first wall brick to the left of the gap suggests that there may well have been an additional brick or bricks here.

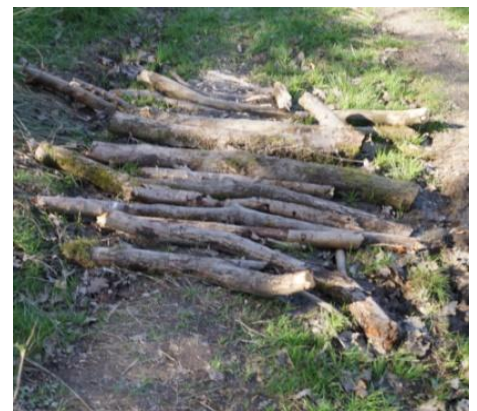
Figure 131. Repairs.

It has been great to see that local residents have been undertaking simple maintenance and repair work.

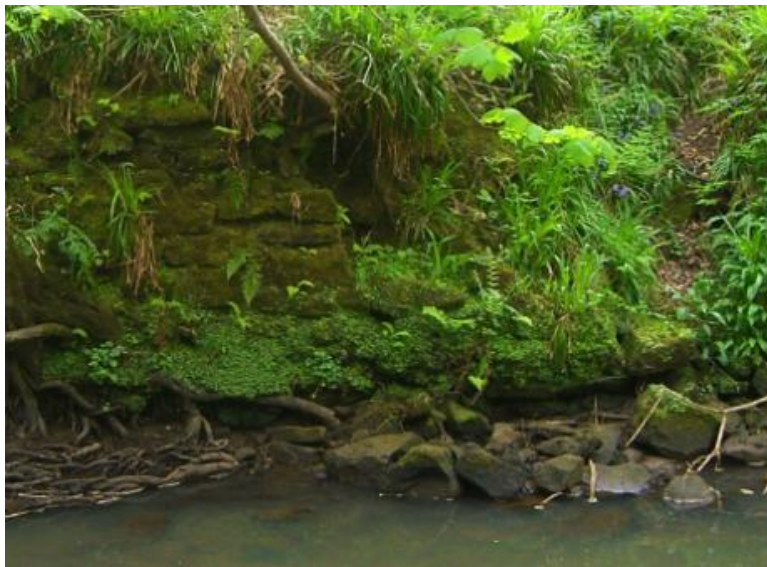
Figure 137. Extensive walling on the west bank.

Some of the walling on the west bank (the pond side) has been extensive at one time.
