Two Estates Project

Clackmannanshire Field Studies Society

The Two Lades Project The Craigrie Lade

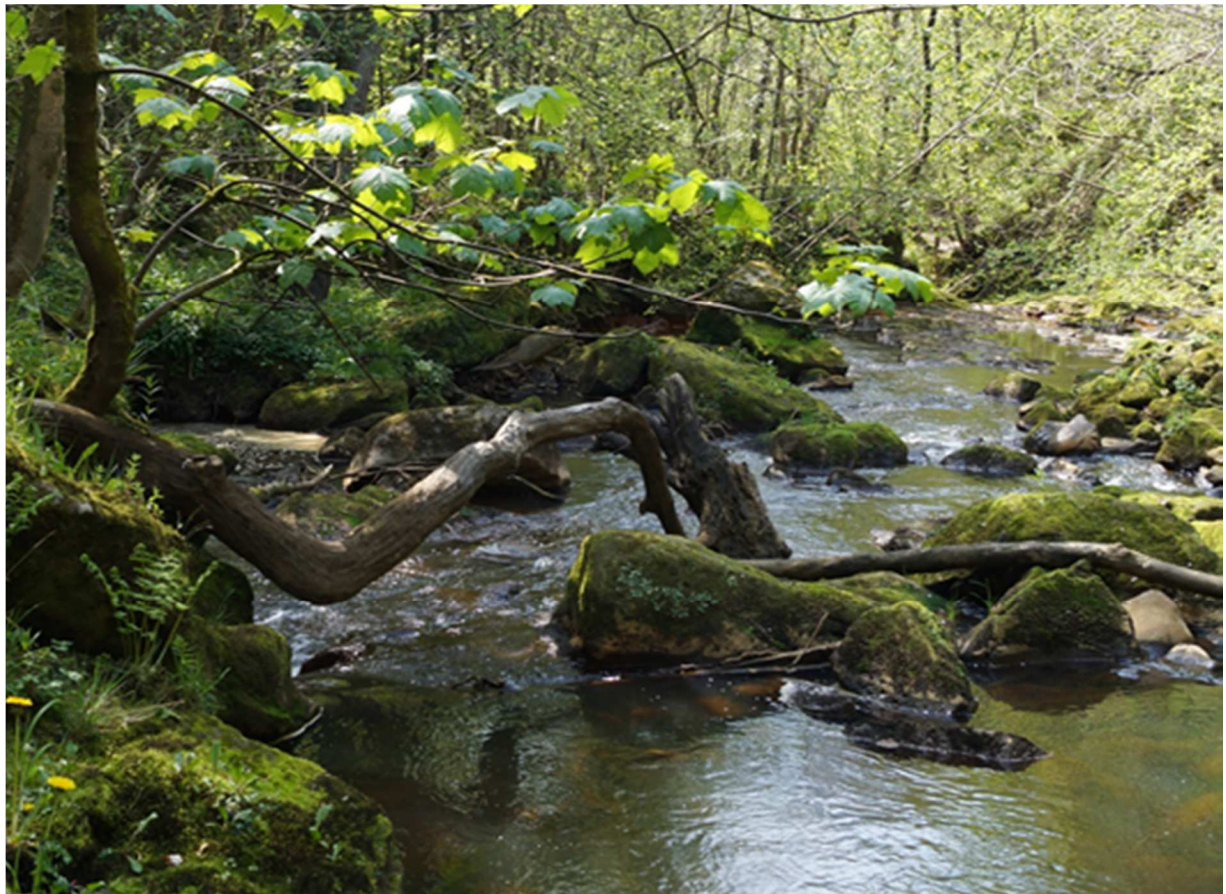
Figure 6. The start of the lade in the course of the river Black Devon.

At this point there is a waterfall with a significant drop in level. We identified the course of the lade just downstream from this point and, using a dumpy level and staff, we surveyed from this first identifiable section of the lade back to the river and confirmed that the water above the waterfall (in the gap beneath the fallen tree branch in the photograph below) is level with the top of the lade.

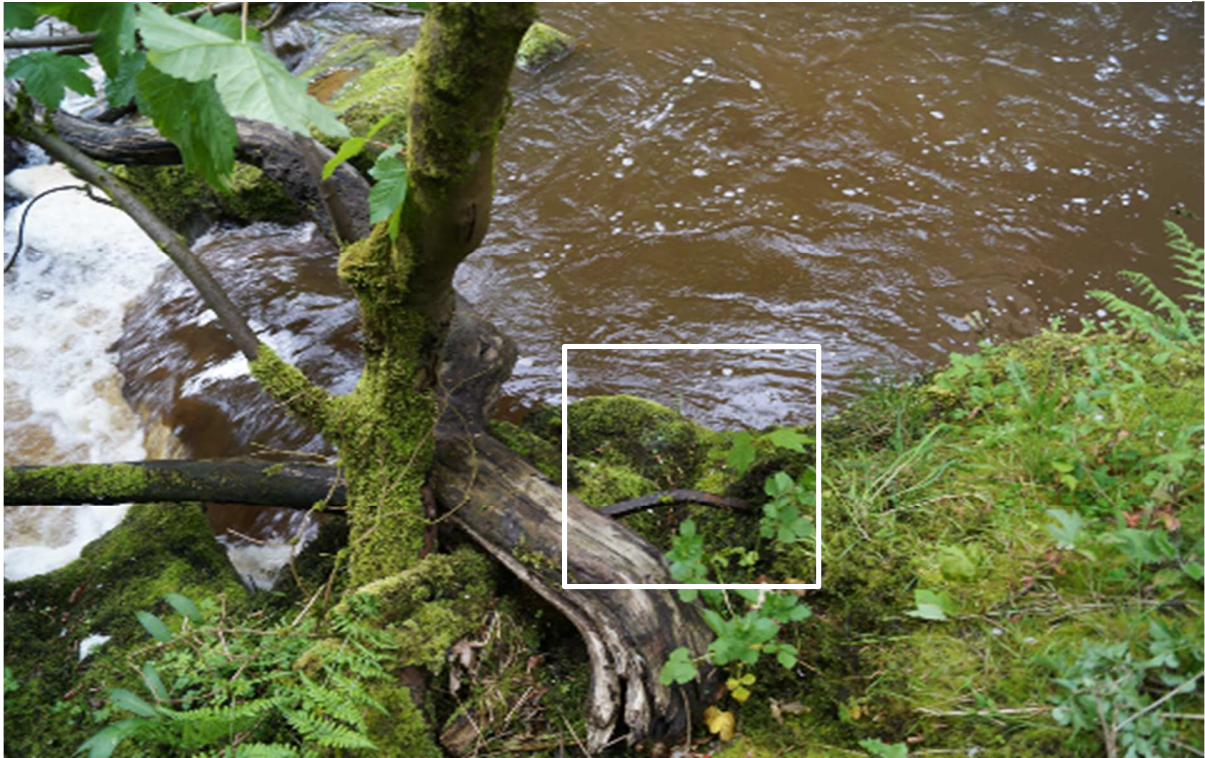
There is a channel on the eastern side of the river where the OS First Edition map shows the lade starting. A bent wrought iron bar has been secured into the rocks at the edge of the river. It is possible that this was used as an anchor point for a short trough, bridging the gap to the start of the cut lade.

This channel, with its firmly embedded wrought iron bar, is a strong candidate for the beginning of the Craigrie lade. Taking the water directly from the river meant that the expense of constructing and maintaining a weir was avoided. The level of accuracy of the survey work which ensured that a lade ending 3.27 kilometres away at the estate pits started in exactly the right place to take water directly from the river is something to be admired, especially given the simple nature of instrumentation available at the time.

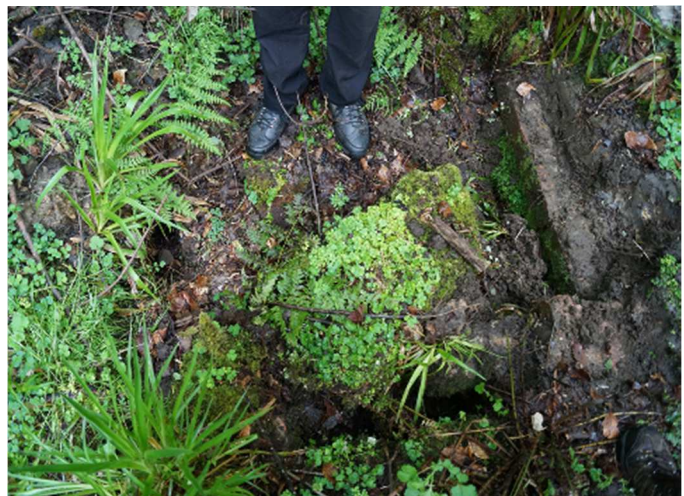
Being in a gorge, at its beginning the lade is partially cut into the bedrock. A short distance from the start we came across this feature in the line of the lade. Due to the wet, stained nature of the infill, we simply noted its basic construction and dimensions. It was made of red, fired, clay bricks and rectangular in shape; with internal measurements of three feet in width and four feet in length (0.91 x 1.22 metres).

This construction was an access manhole related to the pipeline constructed at the behest of the 2nd Earl of Zetland in 1866 to supply the town of Clackmannan with a clean supply of drinking water.

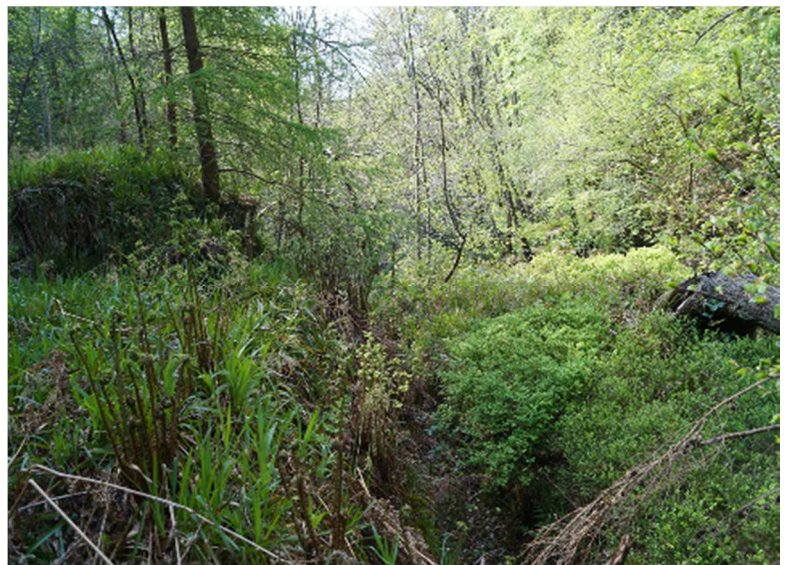
Figure 10. Rock cut ditch.

Below this point, a well preserved rock cut ditch continued. Unfortunately, this section is very overgrown and difficult to access. This ditch carried the lade down the side of the valley, maintaining a level course, while the river Black Devon dropped away through a series of small waterfalls.

A local resident indicated that he had observed two vertical slots cut into the side of the rock, one on each side of the ditch. He suggested that these would have enabled a wooden gate to be dropped to cut off the supply of water to the lade. (53)

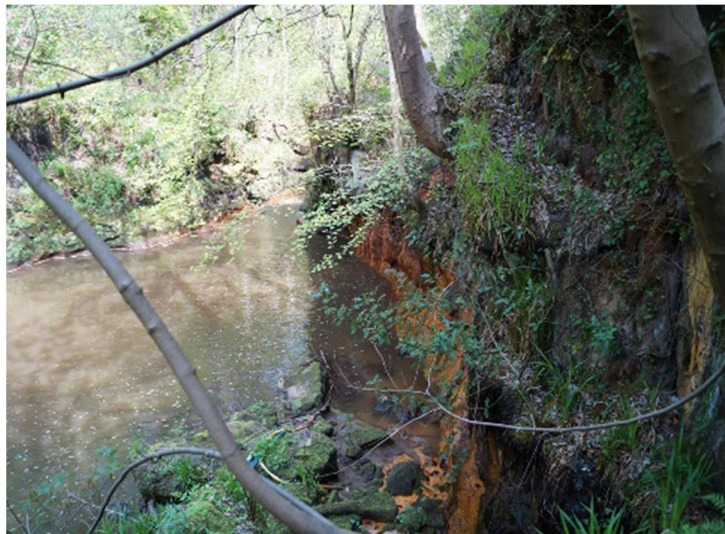
Figure 11. A Gap in the lade.

Just below this section the sandstone cliffs fall steeply all the way down to the bed of the river Black Devon and the rock cut ditch disappears. Two individuals independently reported that they had observed post holes some four inches (10.16 cms) square in cross section in the rocks on the bed of the stream at this point, (54 and 55) They suggested that the lade had been carried across this section in a trough, supported on wooden

posts.

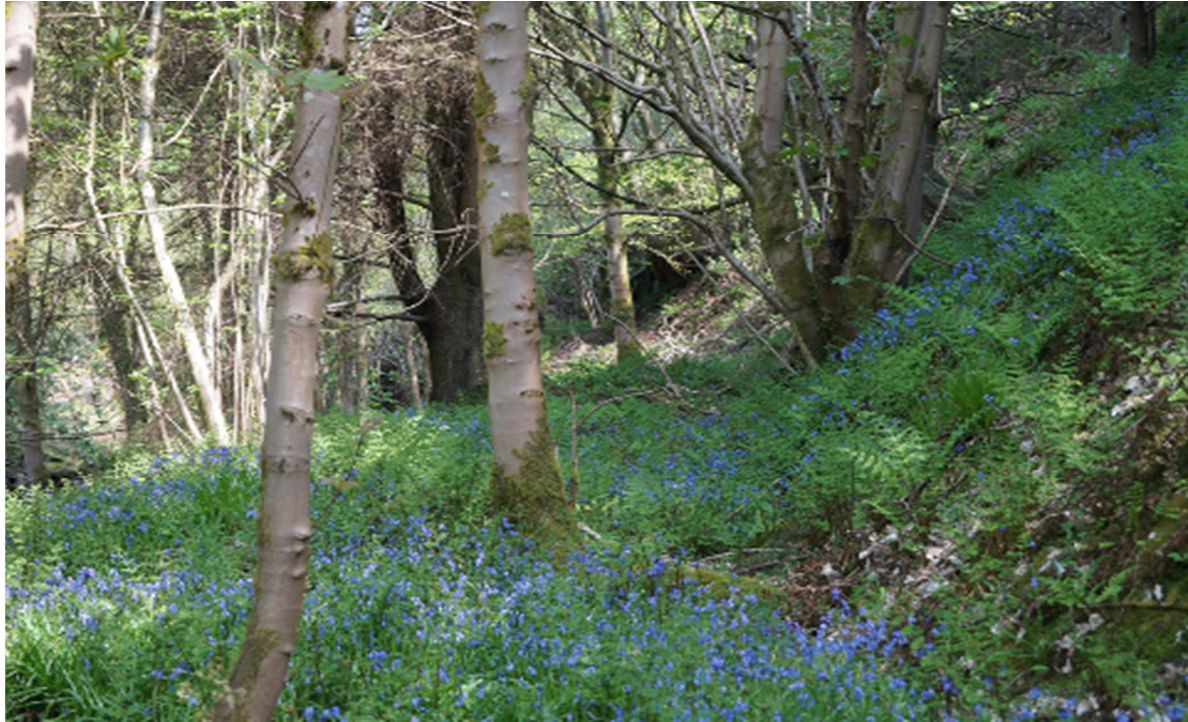
Figure 13. Lade reaches a broader section of the valley.

Here the lade follows the contours along the side of a slope. At this point, the upslope side of the lade still shows small outcrops of sandstone and the cutting angle is very steep.

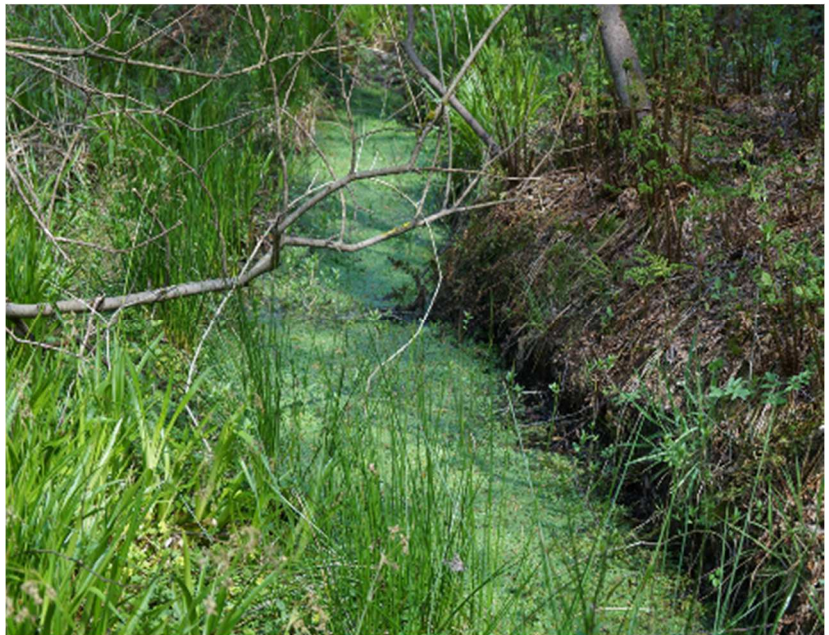
Figure 15. Section of the lade bed re-used as a drain.

Here a small section has been reused as a field drain, to remove water coming down from the slope above. This seems to be related to the planting of deciduous saplings in the bottom of the valley. This section of the valley has a large amount of water draining down the slope and a number of sections of the lade have been washed away.

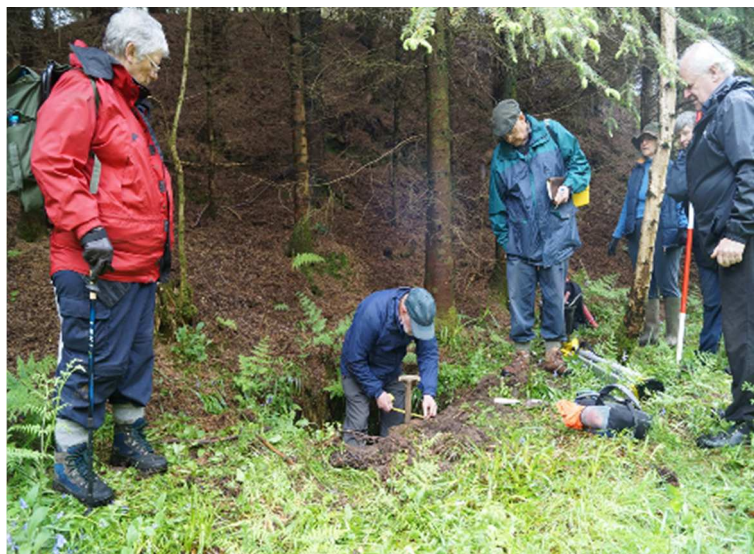
Another brick-built manhole was discovered [NS9243292640]. As the outside walls were undamaged and it was filled with dry material, it was partially excavated, measured and photographed. The internal dimensions were identical to that of the first manhole discovered.

A glazed clay pipe of 18 inches (45.72 cm) internal diameter entered the manhole from the upstream end of the lade and another left from the downstream side. The manhole had been dug down below the level of the bottom of the pipes, creating a sump which would have trapped material coming down the pipe.

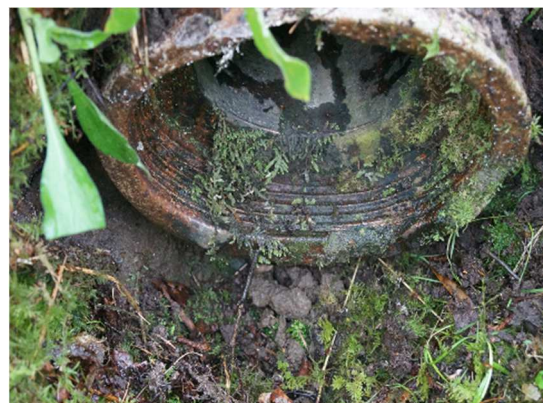
Figure 19. End of drain pipe.

A glazed clay pipe of 4 inches (10 cms) internal diameter led from the bottom of the sluice gate through the upcast bank. This was a spigot and faucet pipe, with a plain end (spigot) and a belled out end (faucet). A thread had been cut into the faucet (belled out) end of the pipe to allow a good mortar seal when the next spigot end was inserted into this faucet end.

There was a sump dug below the level of the pipes, with a drain leading back down into the valley of the river Black Devon. This sluice mechanism would have allowed the manhole, including the sump, to be drained of water to allow cleaning and maintenance.

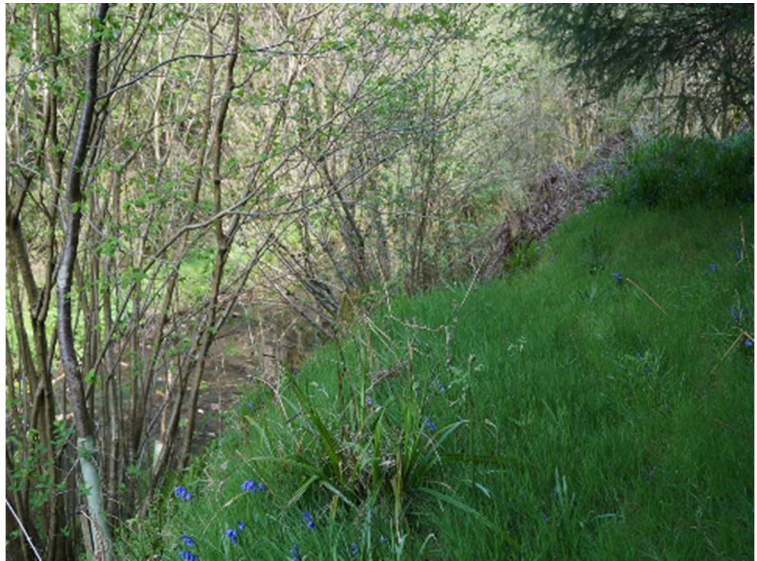
Figure 20. Leaving the river Black Devon.

By this point the river Black Devon was noticeably further away from the level of the lade. The natural slope was still quite steep and the cutting, lade bed top and upcast bank were clearly defined. From the start of the lade, it had travelled through an area of mixed deciduous woodland, with a small number of coniferous trees. The precipitous nature of the route has helped to protect it. Any damage has been related to excessive ground water and recent deciduous tree planting.

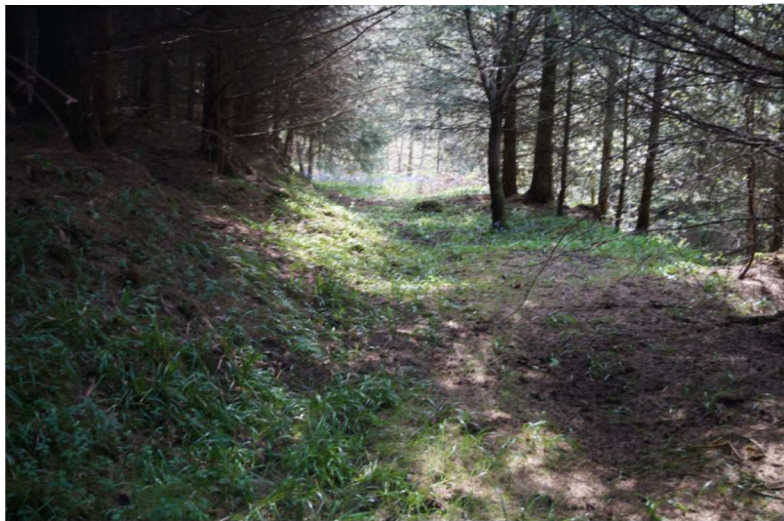
Figure 21. Entering the coniferous plantation.

At this point, the lade enters an area where coniferous planting has been going on for a lengthy period of time. The OS First Edition of the 25 inch map shows a mixture of deciduous and coniferous trees. (56) By 1947 (57) the area alongside and above the lade had been planted exclusively with coniferous

trees. Fortunately, the tree planters had generally avoided the infilled course of the lade bed, perhaps concerned by the softness of the infill.

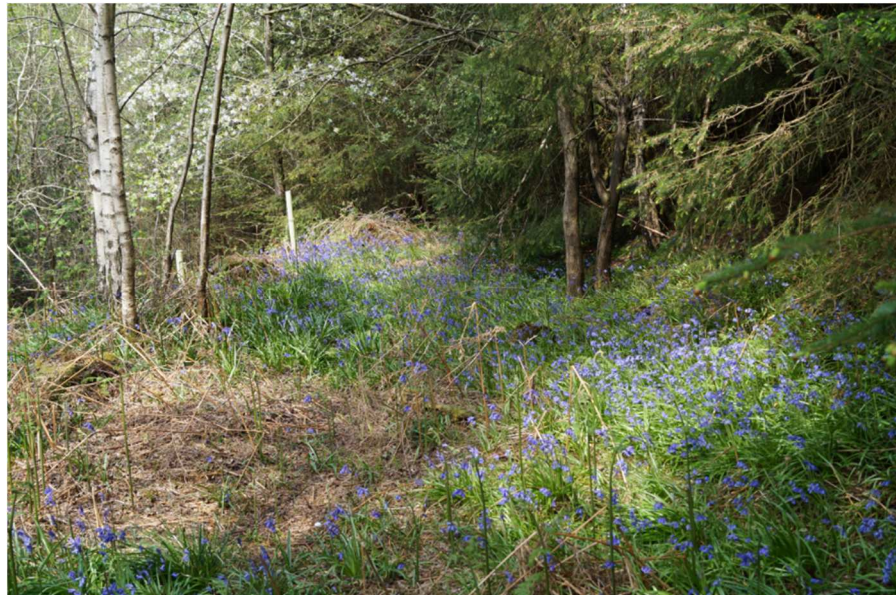
Figure 22. Entering the valley of the Tullygarth burn.

The lade contours gently around the northern shoulder of the valley of the Tullygarth burn [NS9243992555]. The coniferous trees are restricted to the slope above the lade. The bottom of the valley is mixed deciduous woodland.

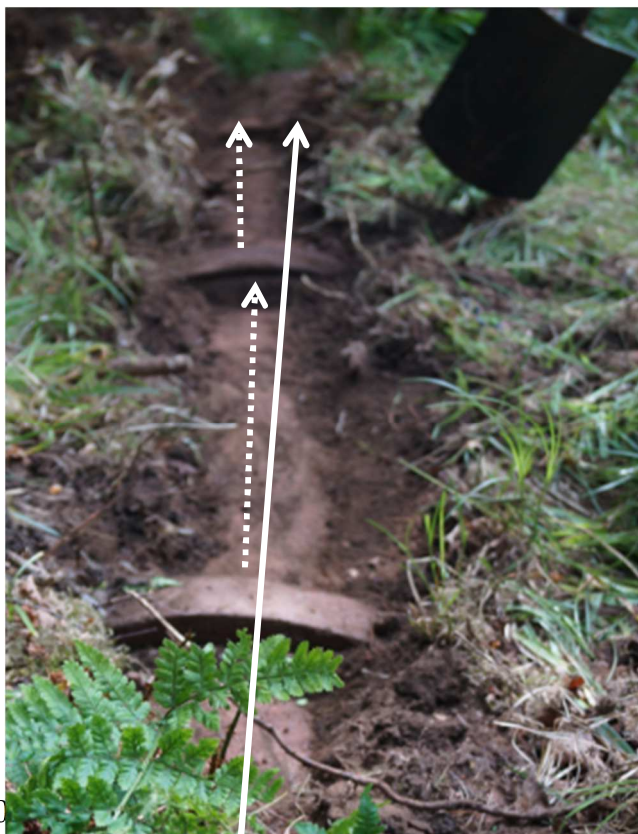
There was a large washed out area [NS9245692553], which had removed the course of the lade. Just at the edge of this, the broken end of a section of pipe from the 1866 Zetland water supply was visible. The line of the pipe at this point pipe had been nearly exposed by erosion, having only a thin covering of turf on top. Several sections of a spigot and faucet pipeline were cleared, giving much more detail about whole sections of pipe and the joints between pipes.

The pipeline at this point had a slight bend to the left. This was achieved by laying each pipe with the downstream (spigot) end a little further to the left. The resultant slight gaps in the joint were filled with extra mortar.

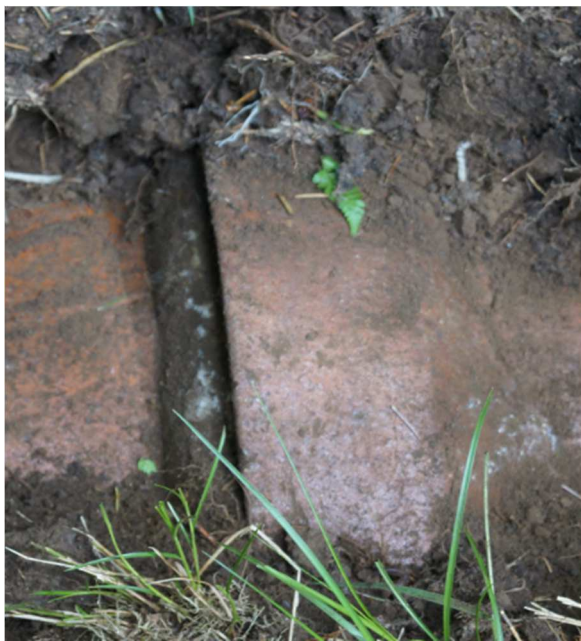
Figure 25. Detail of pipe joint.

The exposure of this section enabled detailed measurements to be made of the sections of pipe. The individual pipes were four feet long (1.22 metres). They were one inch (2.54 cms) thick with a belled out faucet of two inches (5.08 cms). Unfortunately, there was no access to an exposed, complete faucet end.

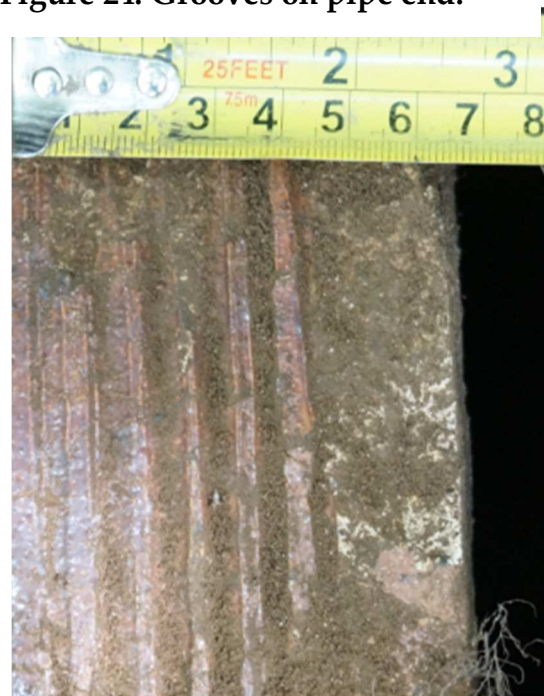
Figure 24. Grooves on pipe end.

The spigot (plain) end of the pipe had been shaped to create six small grooves (2 to 3 mms across) separated by ridges. This is likely to have been achieved by turning the pipe against a former before the clay was fired.

This pattern of ridges and grooves helped to secure the mortar in the joint with the next belled out (faucet) end.

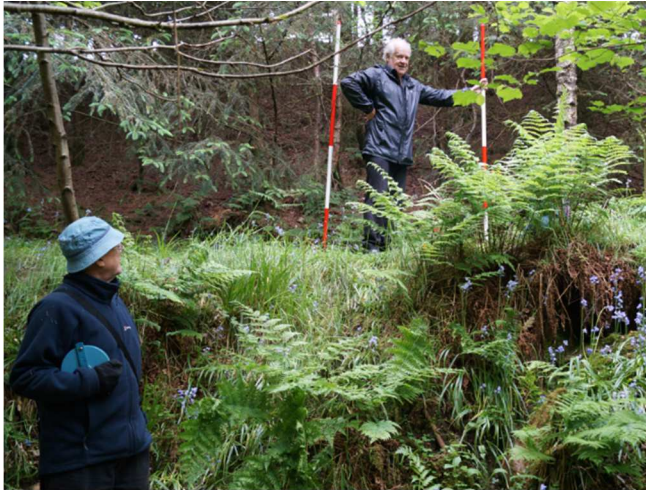
Figure 30. Survey of crossing point.

fence was followed downslope and a ranging pole inserted into the bank of the stream [NS9245392538].

The remains of the next section of pipeline were found, hidden in the undergrowth, just below and to the right of the base of the ranging pole. The section of pipe was cleared. The down valley side of the pipe had been torn away, suggesting that the crossing had been washed out at some time.

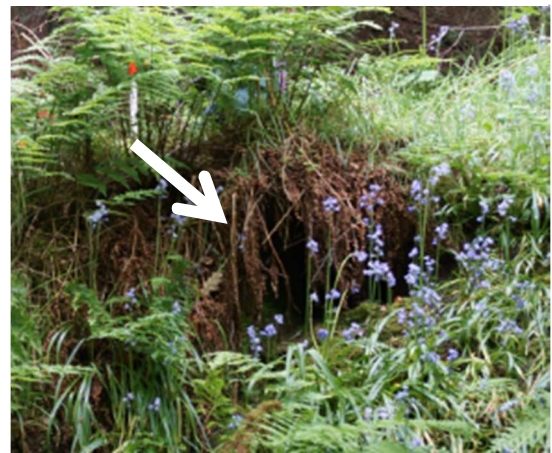
Figure 31. Location of pipe.

Fortunately, modern aerial photographs showed that the field boundary marked on the OS First Edition 25 Inch map above the lade crossing was still present. Using measurements from the map, a line was measured from a clear change of direction in the fence to immediately above the point where the map showed that the lade had crossed the stream. The line at right angles to the

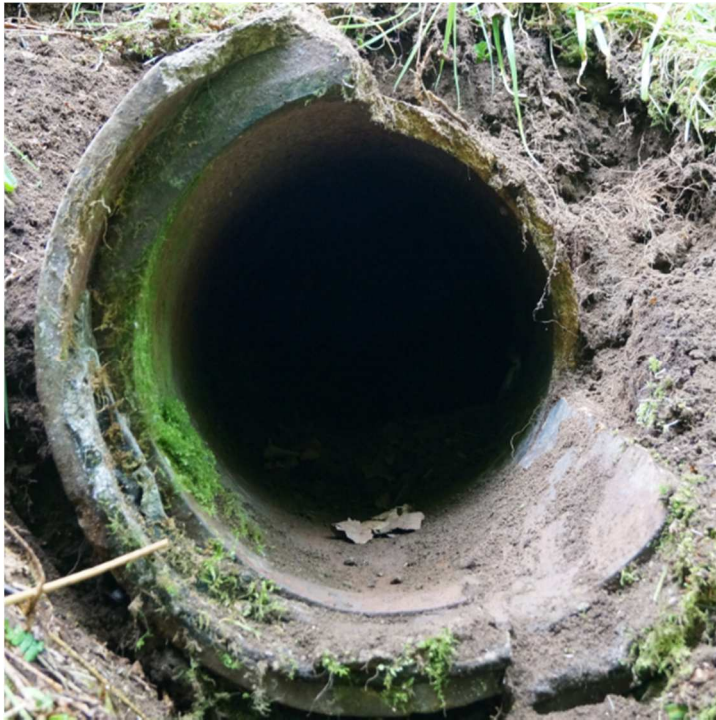
Figure 33. Faucet pipe end details.

Despite the damage to the pipe, it provided good evidence as to the nature of a faucet end. It also provided details of the size and possible manufacture of the pipe sections. The internal diameter of the pipe was confirmed as 18 inches (45.72 cms). The faucet joint consisted of a two inch (5.08 cms) face topped by a two inch (5.08 cms) projection. There was also a very slight widening of the mouth of the internal end of the pipe.

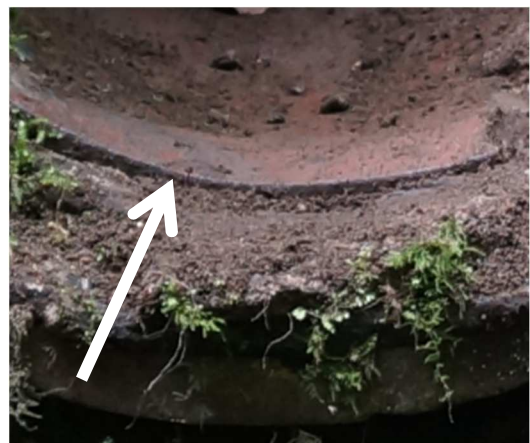
Figure 34. Faucet pipe end detail.

This slight widening showed up as a change in the reflection of light in the inner lip of the mouth of the pipe forming a light rim at the mouth of the pipe (marked with the arrow in the photograph to the right).

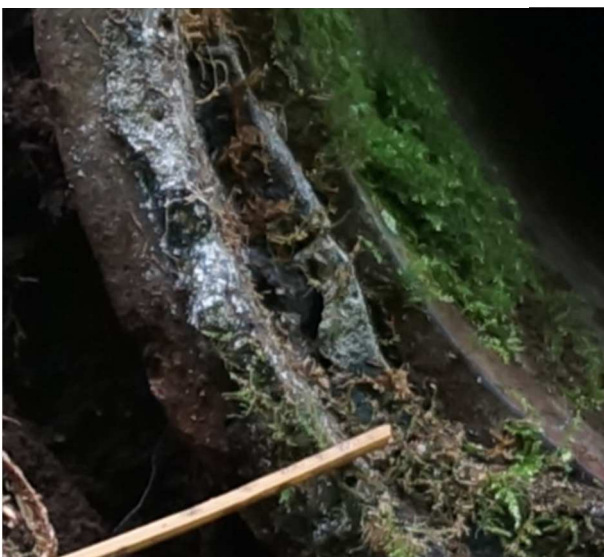
Figure 35. Detail of mortar seal.

The lime and sand mortar had been caught between the spigot end of the next section of pipe upstream and the faucet face of this pipe. It had not completely filled the gap between the two sections.

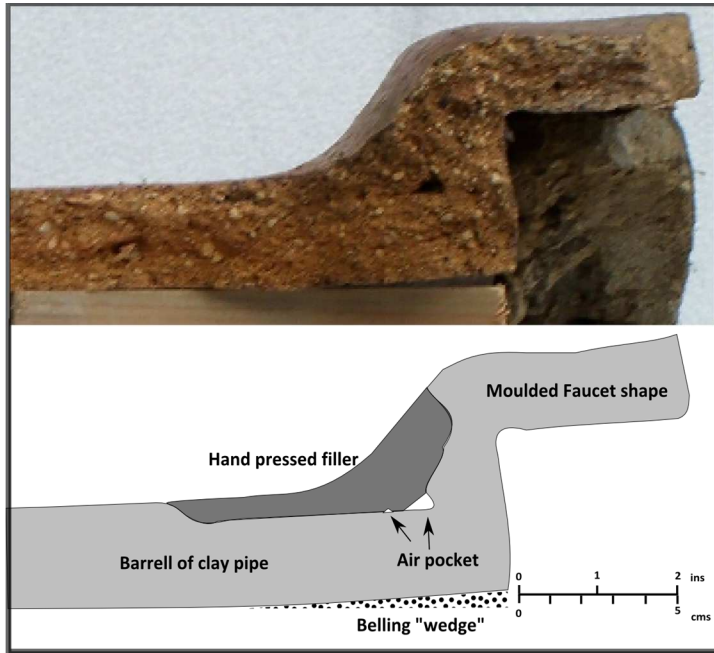
An examination of a broken section of pipe revealed that it was made from a mixture of clay and small particles of crushed material, perhaps old bricks or tiles.

A small broken section of the pipe provided some evidence of the manufacturing process. The colour of the clay mix which forms the “bell shoulder” of the pipe is a slightly darker colour than that of the main pipe. There are small inclusions of air, particularly in the bend. The irregular shape of the faucet form suggests that it was created by forcing a mould into the mouth of a standard cylindrical pipe. The

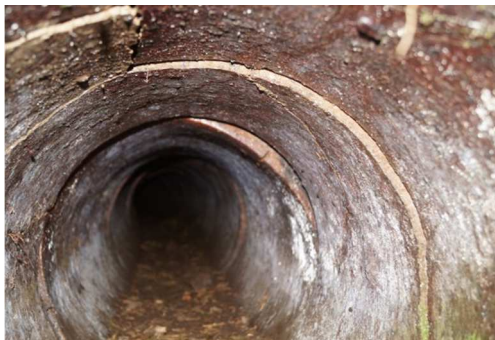
Figure 38. Spigot overlap

deformation of the shoulder was then pressed in by hand, using a slightly different clay mix. In addition, this process created a slight widening of the internal

circumference of the pipe at its mouth, the belling “wedge”. This slight increase in the width of the end of the pipe exposed a short rim of the next spigot pipe end.

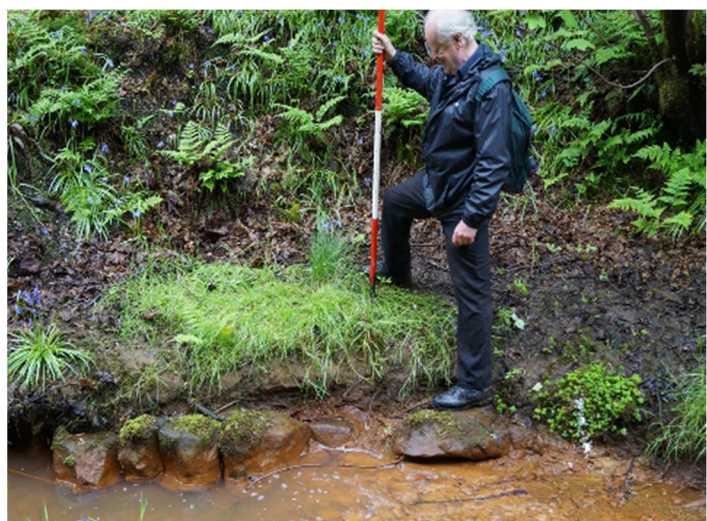
Figure 39. Stone structure in Tullygarth burn.

the Tullygarth burn is shown as entering it. (58) The easiest way to get the lade across the burn and capture the water coming down it would have been to build a dam across the burn. Exploring the bed of the Tullygarth burn, a bed of laid sandstone blocks was found close to the point where the OS map showed the lade had crossed.

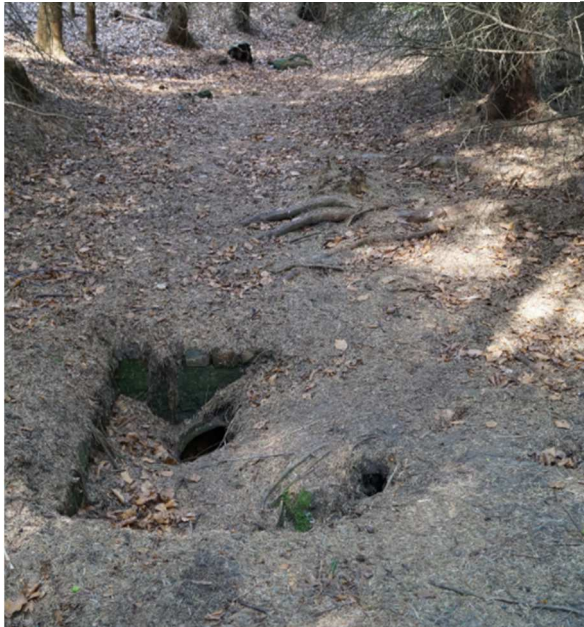
Figure 40. Tullygarth burn manhole.

The remains of another brick-built manhole were found in the line of the lade [NS9242292532]. This was partially excavated to reveal the main features.

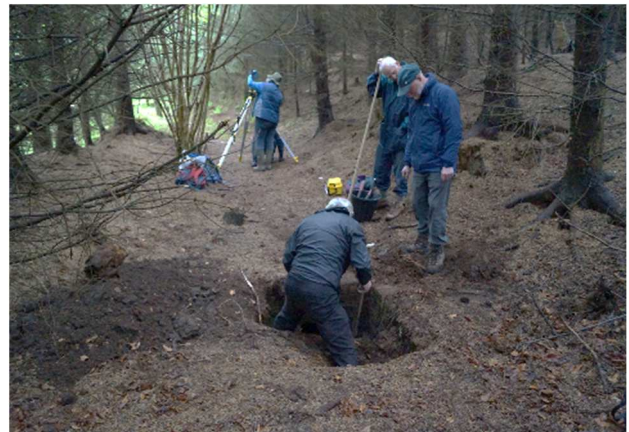
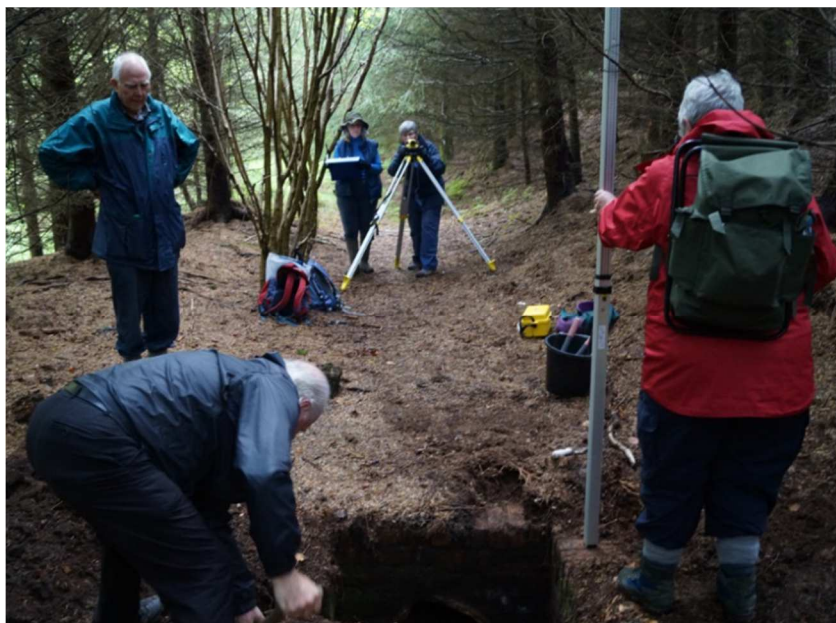
The walls were made of two rows of well-made red bricks, nine inches by four inches by three inches (22.86 x 10.16 x 7.62 cms) with a lime and sand mortar. The internal dimensions of the manhole were 3 feet wide and 4 feet long (0.91 x 1.22 metres).

The bottom of the pipeline was three feet (0.91 metres) below the top of the infill level of the lade bed. The horizontal area of the top of the infill was consistently six feet (1.83 metres) wide. This suggests that the original lade bed was a three foot deep by six feet wide (0.91 metres x 1.83 metres) ditch.

The brickwork was laid on top of a concrete base, of unknown thickness. Two glazed, fired clay pipes were located at either end of the manhole. On the upstream side a spigot-ended pipe of 18 inches (45.72 cms) internal diameter entered the manhole. A similar sized faucet-ended pipe led out from the downstream side. (Spigot is a plain end to a pipe which fits into a belled out other end of the next pipe, the faucet end). Unfortunately, the faucet ended pipe had been damaged.

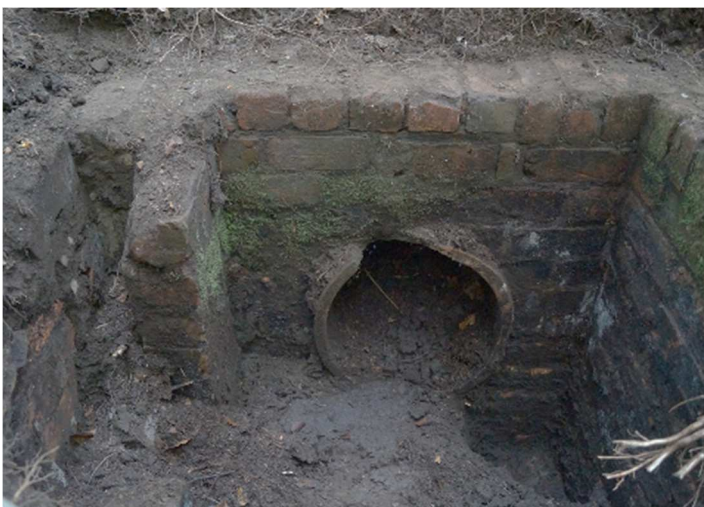
Figure 44. Drainage Sluice.

The Tullygarth burn side of the manhole had an entry into a brick-wide space. At the base of this was a four inch (10.16 cms) diameter glazed clay drain pipe which led through the upcast bank into the valley of the Tullygarth burn. Again, a wooden sluice gate was fitted into the space to seal off the drain. The standard of brickwork was practical, but rough. In order

to create a seal around the wooden sluice gate, the space between it and the brickwork had again been packed with lime and sand mortar. There were four courses of bricks creating a foot (30.48 cms) deep space below the level of the pipe. This would have acted as a sump to catch loose material which had been carried down the pipe. When excavating into this area, the material turned from loose debris to stiff, sticky clay.

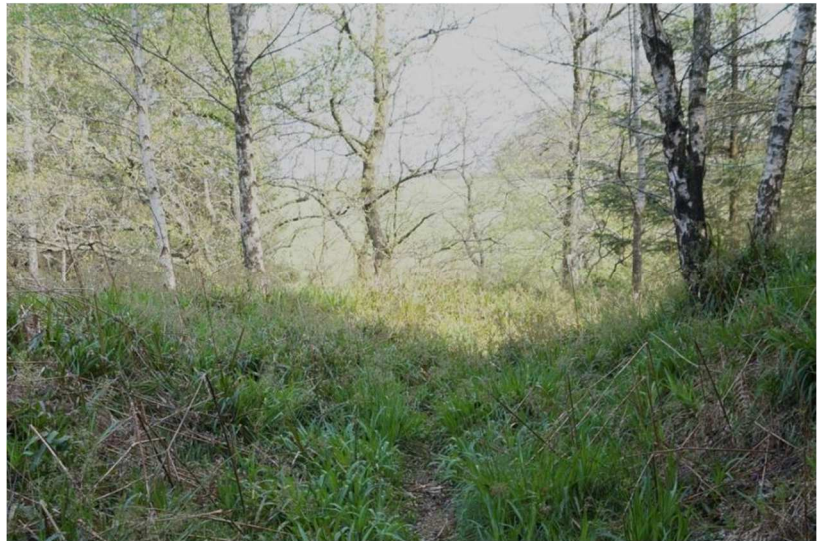
Figure 48. Lade between viaduct and the Tullygarth

The lade continues along the shoulder of the valley of the Tullygarth burn and then down the eastern shoulder of the valley of the river Black Devon.

The form of the lade is extremely well preserved at this point, with a steep upslope cutting, well developed lade bed and upcast bank.

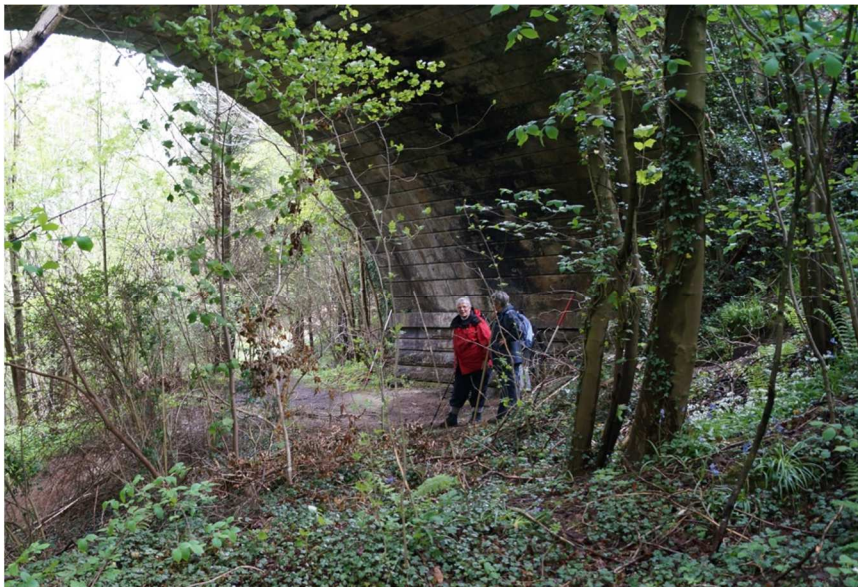
Figure 49. Lade passing under the railway viaduct.

The Stirling to Dunfermline railway reached Clackmannan in 1850. (59) This large stone built viaduct [NS9229592482] carried the railway across the river Black Devon and the course of the lade. The lade nestles under the eastern end of the arch of the viaduct and its bed is now a

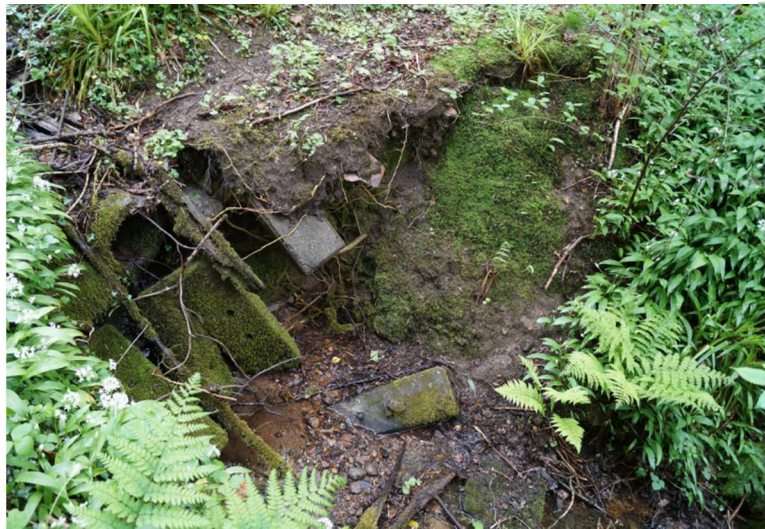
Figure 50. Lade and path washed out.

The lade crossed a small stream and the lade crossing and pathway have been washed out. The path was moved upslope onto a new line, with a wooden bridge now crossing the stream. The present pathway can be accessed from the roadway to the old Cherryton brickworks site [NS9230392298].

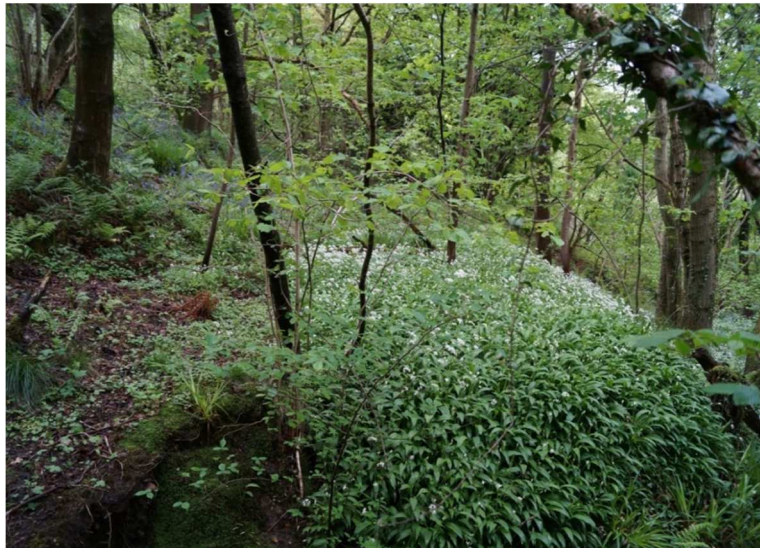
Figure 51. Lade Bed through woodland.

The line of the lade continues through the woodland until it reaches the roadway to the old brickworks. As it has been used as a pathway, its form is altered, looking more like a roadway than a lade.

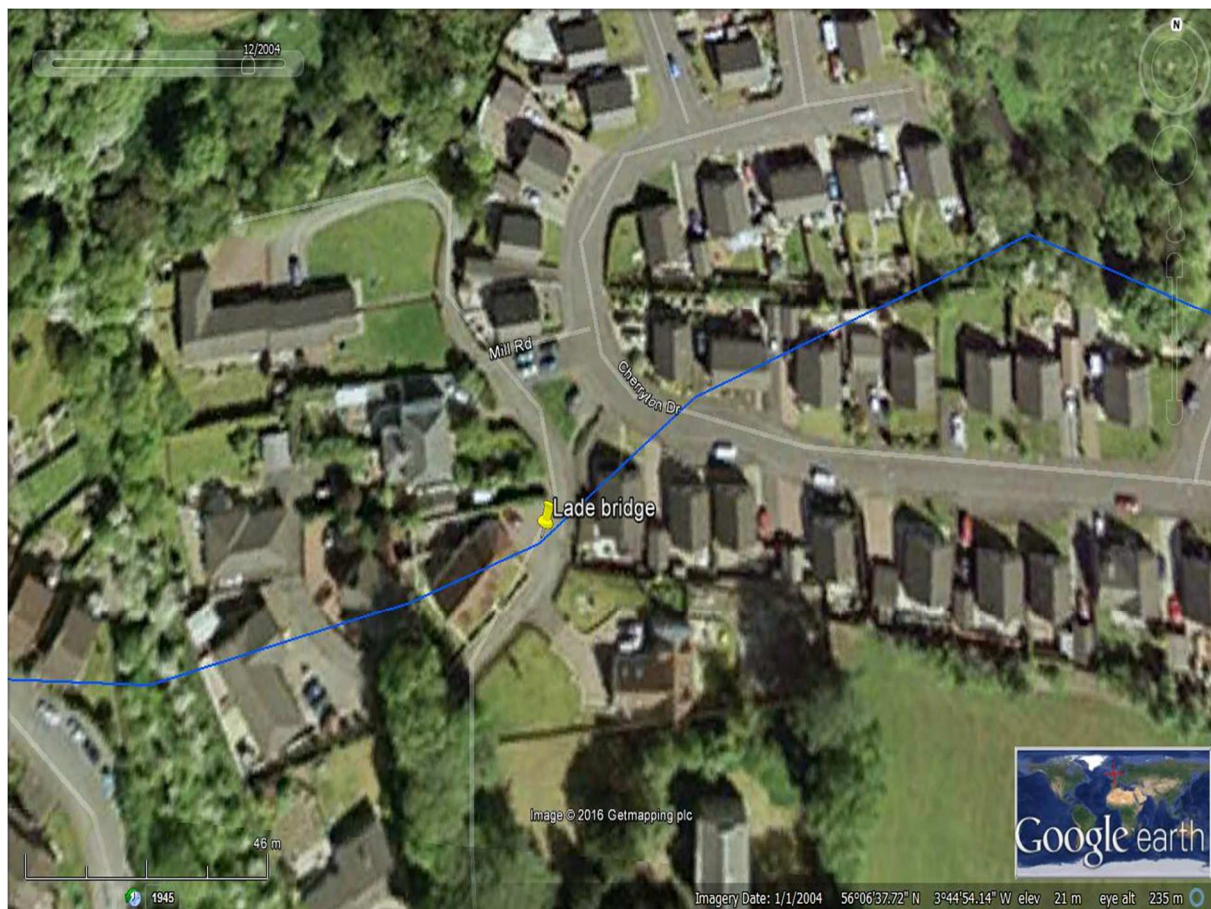
Figure 53. Location of Lade Bridge.

Fortunately, in constructing a driveway for his house, Ian Russell uncovered the remains of the old lade bridge and distillery building shown on the OS First Edition 25 inch map of 1862 and measured and draw sections of them. We are grateful for his permission to include his sections here.

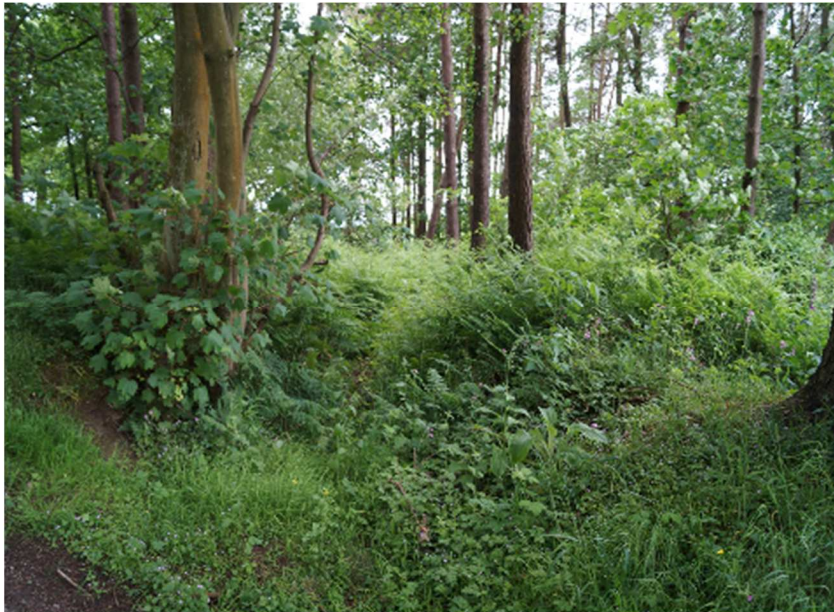
Figure 56. The Craigrie lade on the Back Wood.

The remains of the lower section of the Craigrie lade were identified by walking up the fence line to the west of the modern blocks of flats at Backwood Court [NS908922]. The fence is on the same line as the one shown on the OS First Edition 25 inch map of 1862 (60) and we were able to confirm the location of the lade [NS9078492176] by measuring down from the Tower Park to the edge of the lade. This whole area is underlain by glacial clay, into which the lade has been cut.

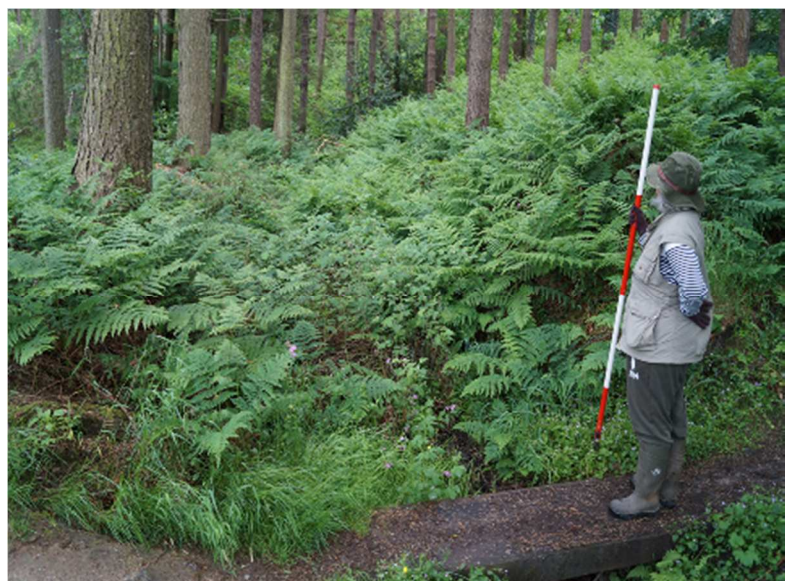
Figure 57. Lade continues through the Back Wood

The lade bed is still evident all the way through the Back Wood as a substantial ditch, contouring the slope. The area has been planted with coniferous trees but, as in the case of the upper section of the lade, they have not been planted in the lade bed.

A number of recently built pathways cut across the line of the lade. While some have caused minor damage to the lade bed, many of them have been bridged across the lade, leaving the line intact. The network of pathways offers easy access to the line of the lade from the public footpath along an old waggonway through the Back Wood from the B910 next to the Mary Bridge [NS9085292253] to the western edge of the Back Wood [NS9037592295]

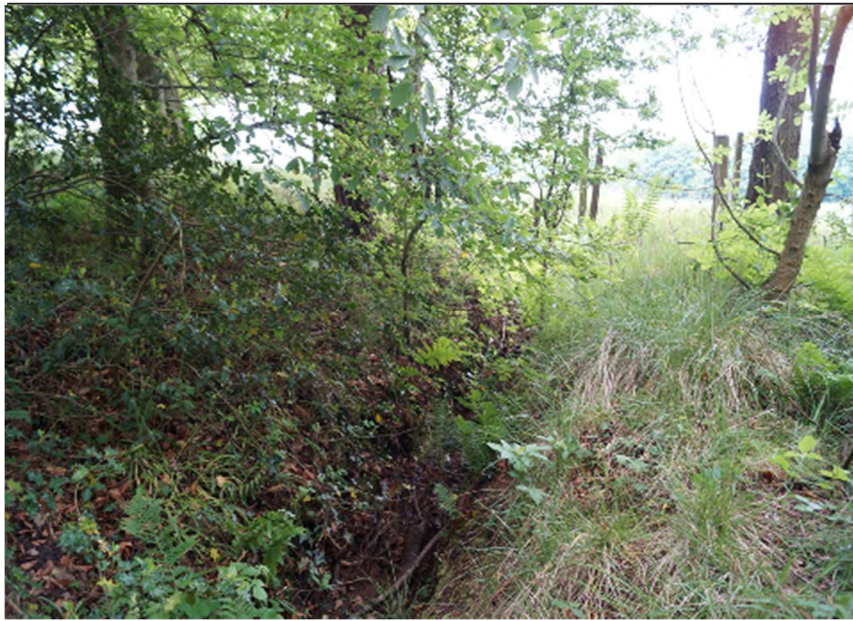
Figure 58. Lade exits the wood into the Craigrie Farm.

Eventually, the lade crosses over from the Back wood into the fields of the Craigrie farm on the western slope of Kings Seat hill [NS9039192251]. The lade is cut into the slope, with the material from the cutting and the construction of the lade bed being used to create an upcast bank on the downslope edge.

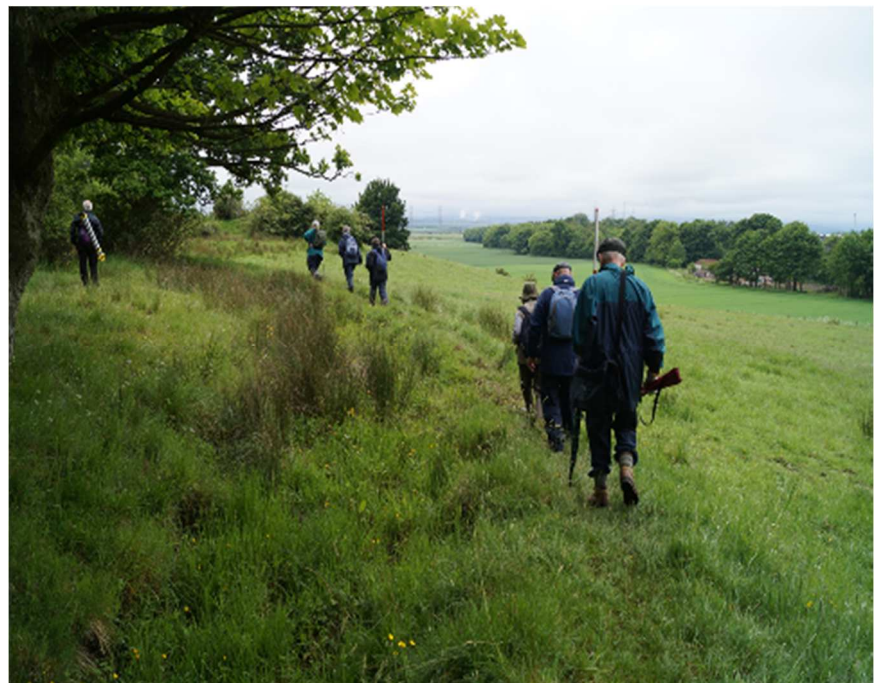
Figure 59. The lade contours round Kings Seat Hill.

This area is a large grass park with a linear area of trees and bushes along the course of the lade. In addition, there are still many trees and bushes along the former field boundaries. Two very small sections of the lade have been lost; one where a footpath crosses its line and another where cattle have eroded it in passing. Apart from this, the line of lade is well preserved until the last 150 metres, where the line has been ploughed out.

The existence of the trees and bushes around the lade have been of significant value in protecting its line since it was abandoned.

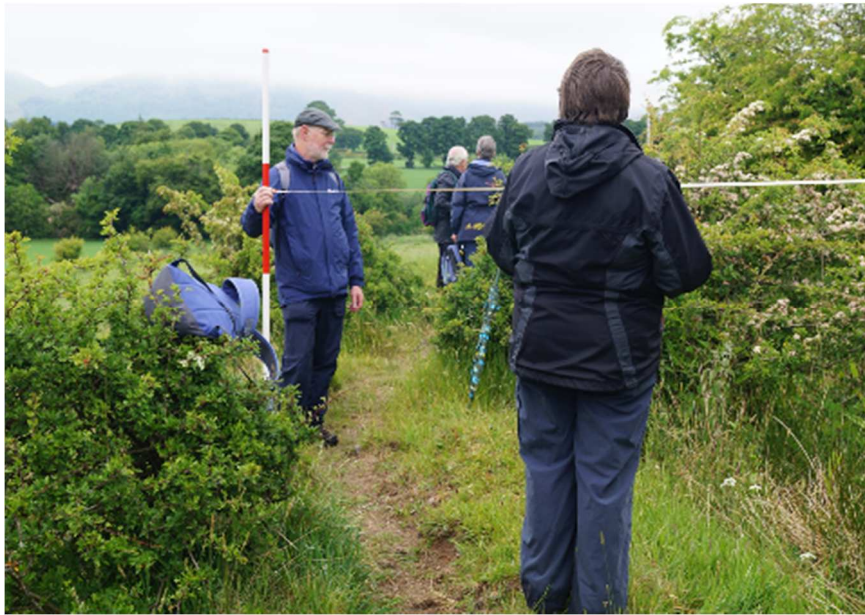
Figure 60. Surveying the profile of the lade.

A number of sections were surveyed to establish the profile of the lade as it neared its end point. The manner of the lade's construction reflected the underlying glacial clay material. A simple cutting was made, using the material excavated to create an upcast bank on the downslope.

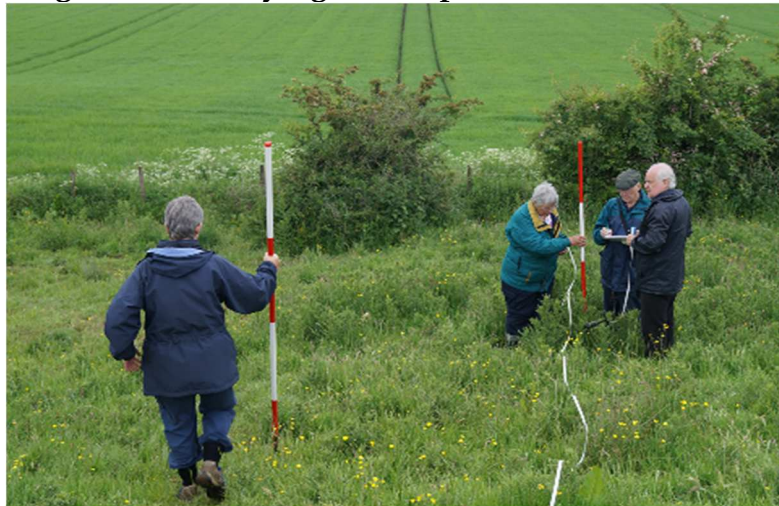
Figure 62. Surveying the drop from the Lade.

Having finally arrived close to the site of the old Speedwell pit, it was clear that the line of the lade was considerably higher than the site of the pit. Surveying down from the lade to the old waggonway adjacent to the pit site showed a drop of 10 metres (32.81 feet).
