Two Estates Project

Clackmannanshire Field Studies Society

The Two Lades Project The Craigrie Lade

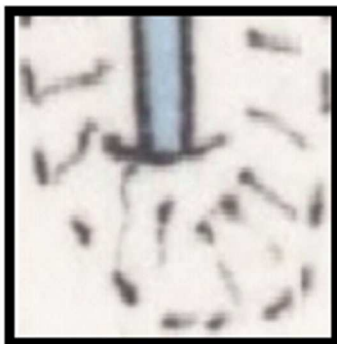
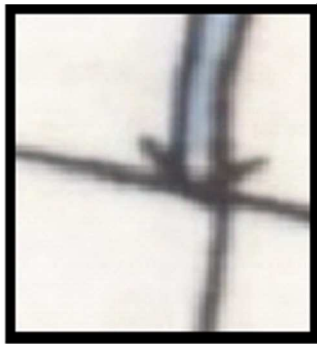
Figure 66a. Lade entering the ground.

The OS First Edition of the 25 inch map gives indication of locations of syphons. (63) The lade is shown as entering into the ground at two points; at Riccarton and at the end of the lade at the northern edge of the Craigrie farm steading. In both cases the same graphic is used.

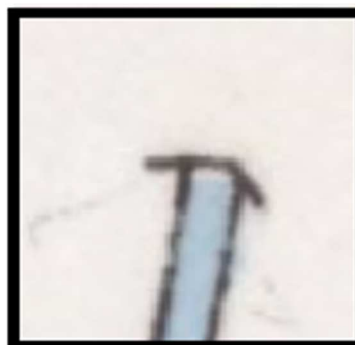
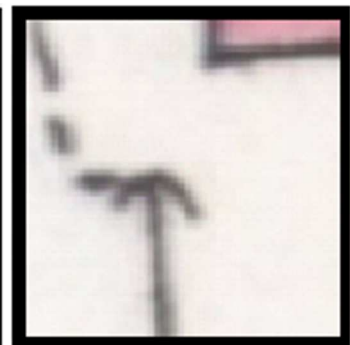
Figure 66b. Lade exiting the ground.

Two instances of the lade emerging from below ground are shown, at Riccarton and at the site of the Craigrie pit. Again, in both cases, the same graphic is used. This suggests that the Craigrie lade finally entered a syphon at [NS 902523911720] and ended somewhere in the area of the site of the Craigrie pit [NS 904915].

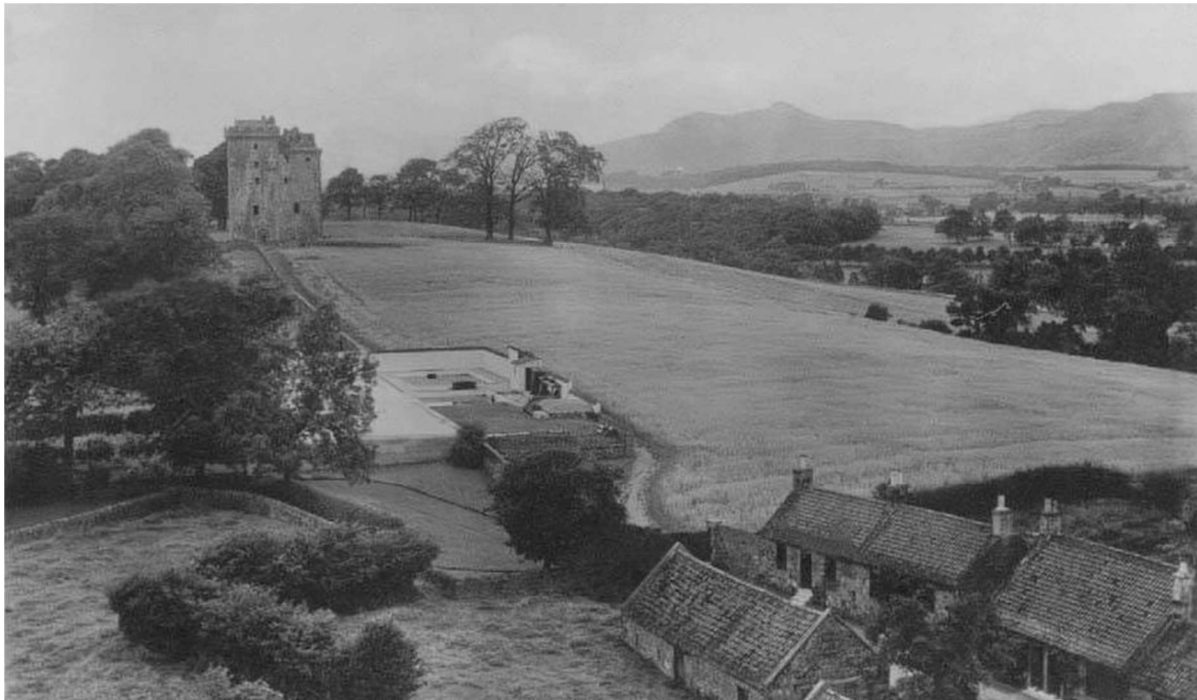
Figure 67. Clackmannan County Council Water Works and site of storage tank.

This old postcard was shot from the top of Clackmannan Church tower. It shows the Clackmannan County Council water works (with most of the walls painted white), the cottages at the top of the High Street and the road to Clackmannan Tower. The site of the Zetland storage tank was in the bottom right hand corner of the water works. The road from the High Street to the Tower still retains its dog leg.

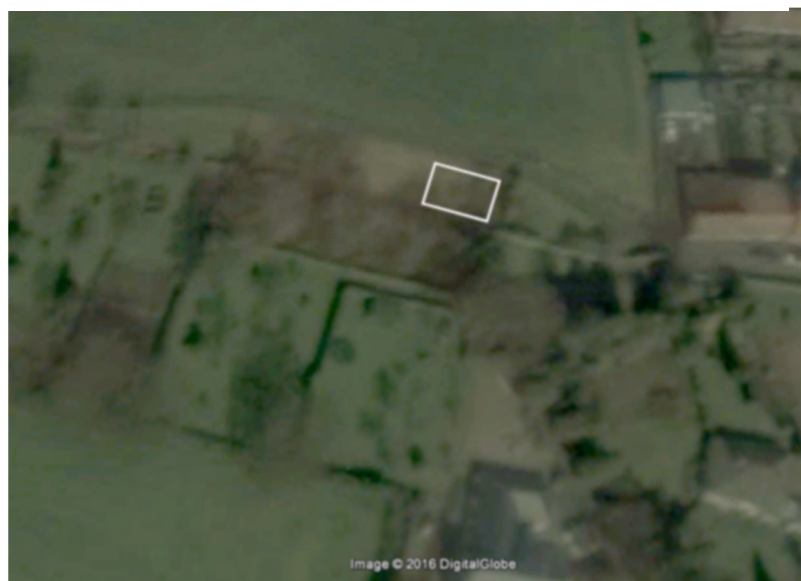
Figure 68. Modern aerial view of storage tank site.

The water works and the site of the storage tank (white rectangle) is now an overgrown tangle of brambles and weeds. The dog leg in the road to the Tower has been preserved.

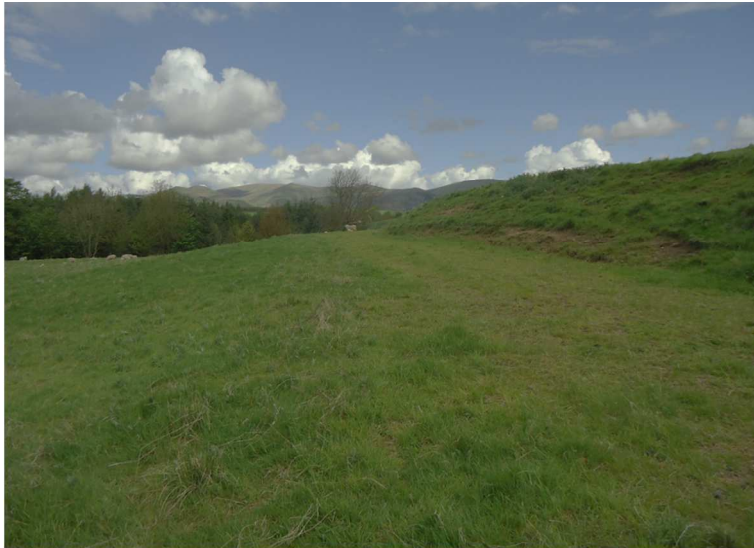
Figure 69. Track leading to Tullygarth burn.

A track leaves the cycle path, heading towards the line of the Tullygarth burn [NS9264792453]. The width of the track was about 10 feet (3 metres). There were signs that the bank to the east had been cut into recently to make it wider. There was a very slight ridge on the downslope edge of the track.

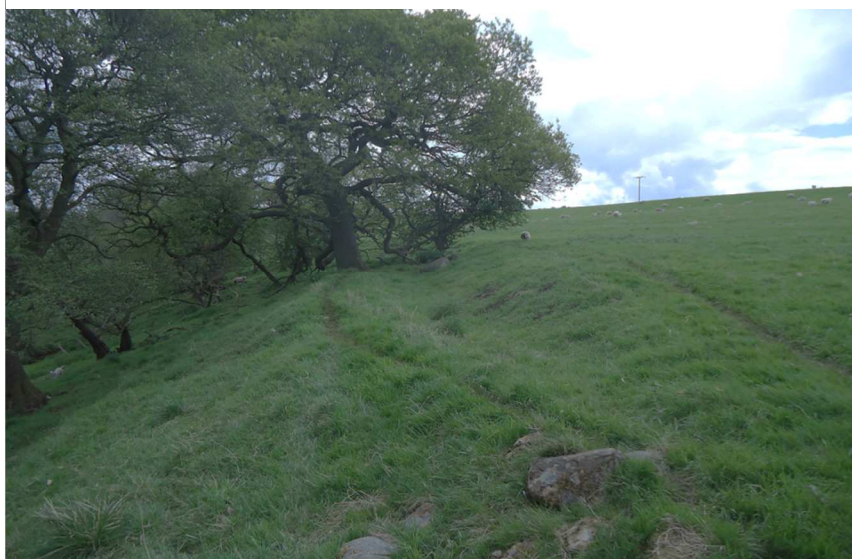
Figure 71. Remains of the Tullygarth lade.

On reaching the point where the track crosses the Tullygarth burn a well preserved section of lade was found, contouring down the south side of the Tullygarth burn [NS9274092582]. The most westerly part of the section turned southwards towards the line of the track (bottom

right hand corner of the photograph above). The lade continued eastwards towards the site of the Garrison Dam. Upstream, the steep slope of the valley of the Tullygarth burn, together with mature trees and hawthorn bushes, have protected the lade from ploughing.

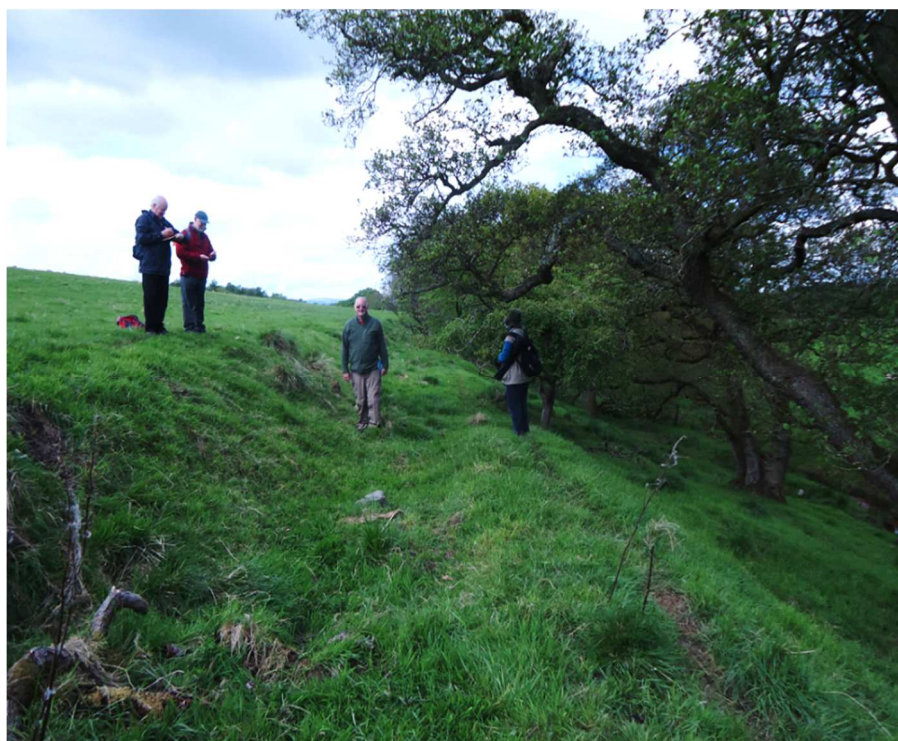
Figure 72. Centre section of the lade.

The centre section of the lade was well preserved. It was located at the top of the steeper section of the valley of the Tullygarth burn. The bank had been cut back and the spoil, together with that from the excavation of the lade bed, had been used to create an upcast bank below.

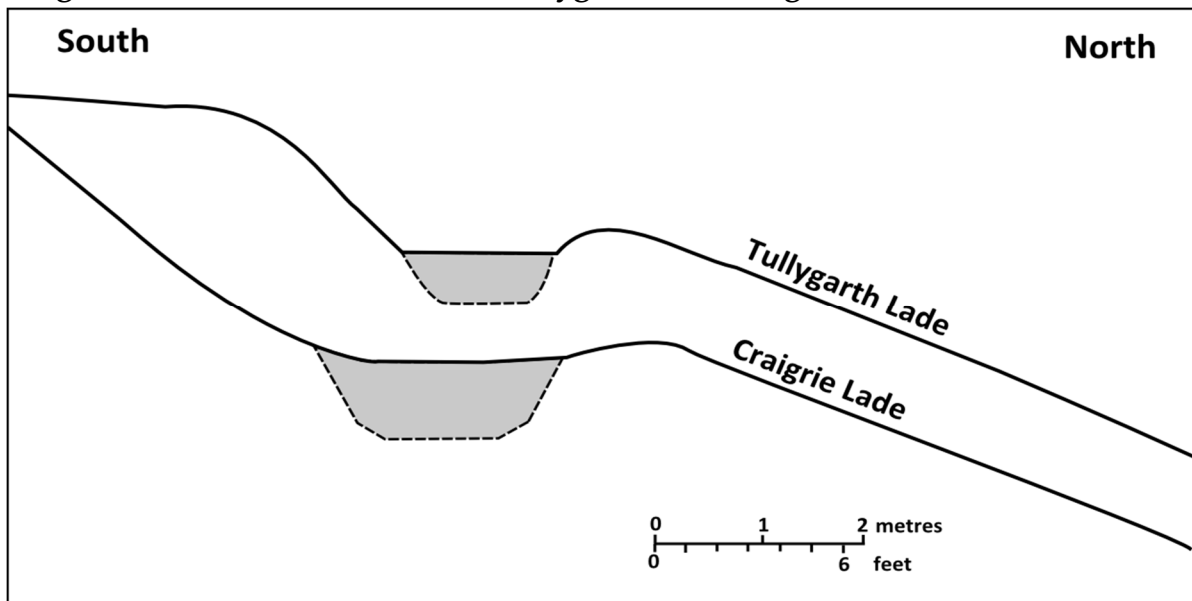
The profile of the lade was surveyed and compared with that of the Craigrie lade at the foot of the Tullygarth burn. The Tullygarth lade was considerably smaller than the Craigrie lade.

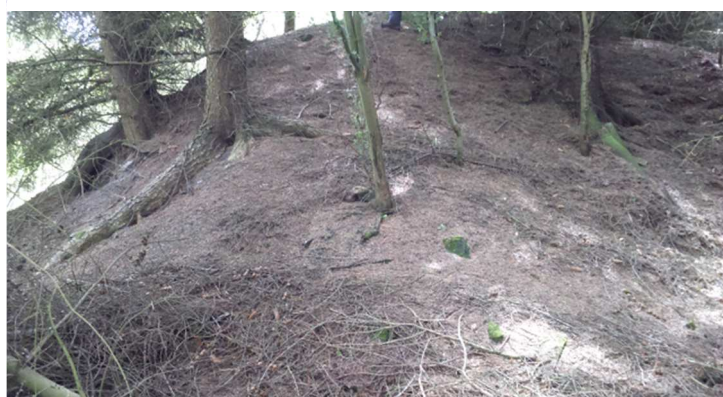
Figure 76. Pit spoil heap at the Garrison Dam.

The size of the spoil heap of the mine next to the Tullygarth burn reflects the small size of the working. The presence of these two pits indicate that the Garrison dam had been abandoned prior to 1861.
