Two Estates Project

Clackmannanshire Field Studies Society

Alloa Estate Project

The Alloa Pond

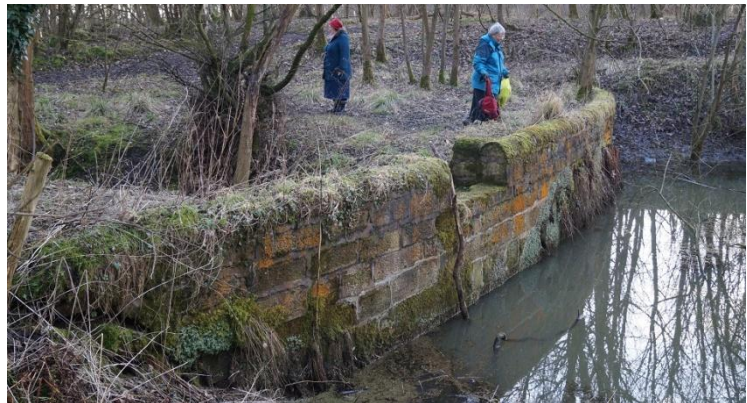
Figure 6. The pond dam, 2015.

The level of water in the pond was some one and a half metres below the top of the dam wall and the nature of the vegetation on the banks of the pond suggested that the water in the pond had been at this level for some time. There was no indication of any substantial flow of water into the pond.

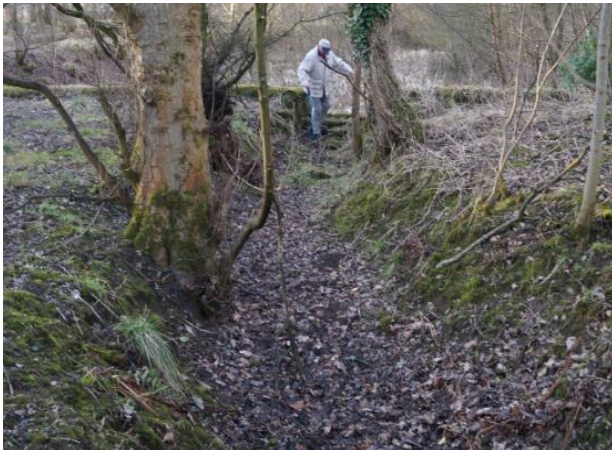
Figure 7. The pond dam overflow, 2015.

The dam consisted of a level, earthen bank with a pond-facing arch built of well cut, ashlar blocks of sandstone. There was a channel built into the dam with a ditch leading into the river Black Devon. This channel was a stepped overflow designed to ensure that the level of water behind the dam did not rise above a certain level.

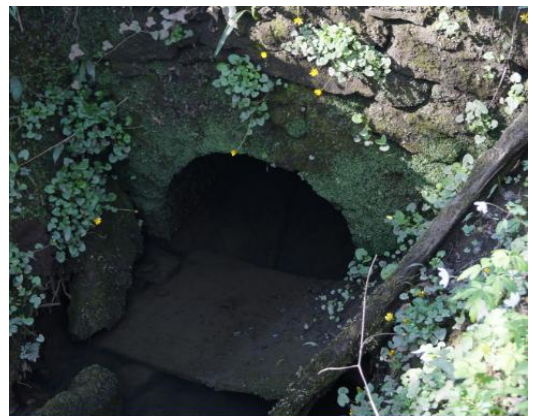
Figure 8. The pond drain, 2015.

Under the water level close to the centre of the dam wall there was evidence of a drainage sluice. A circular metal drainage outlet was set at a depth of about two metres some two metres to the south west of the edge of the overflow channel. This appeared to connect to a stone-built outlet at the edge of the river Black Devon. Although the level of water in the dam was quite low, there was a distinct flow from the outlet.

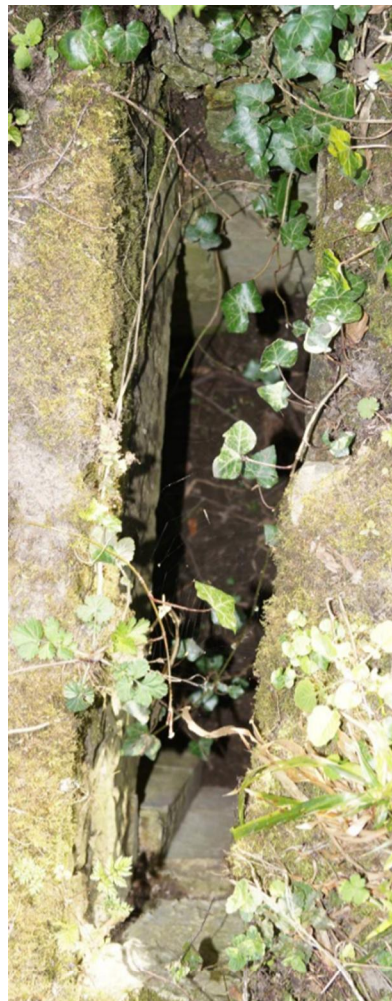
Figure 9. Niche for gate.

The north end of the pond was connected to the bank of the Black Devon by a substantial ditch. The ditch starts at the bank of the river from a well-built stone sluice which has a slot cut to hold a sluice gate.

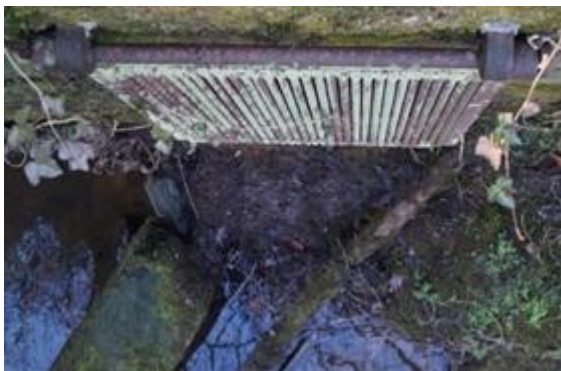
Figure 10. Metal grill at inlet sluice.

There is a hinged metal grill on the river side of the sluice. This would have kept debris from entering the sluice gate.

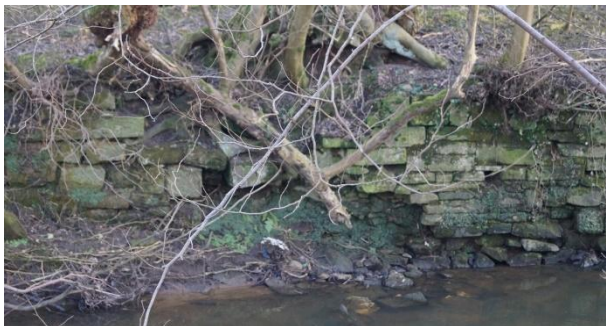
Figure 11. Remains on the East bank.

There is a similar stone-built structure on the opposite bank of the river Black Devon which also has a plain, unbroken surface.

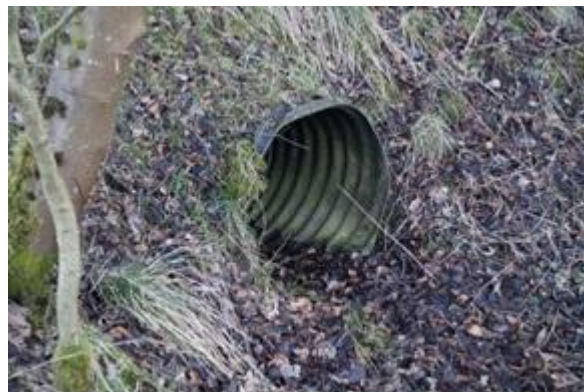
Figure 12. Path over inlet lade at pond.

Following the ditch towards the upstream end of the pond confirmed that it continued as a simple earth-cut ditch. Close to the pond a corrugated iron pipe had been inserted into the ditch and earthed over to provide a pathway across.

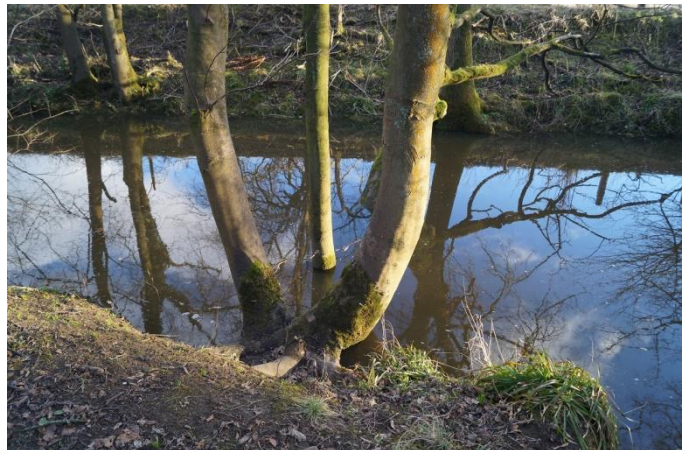
Figure 13. River with highest tide

The detail of the 1871 estate plan was not available at this time and there had been considerable debate about a source of water for the pond. Suggestions had been made that it might have been filled at a high tide. A second visit was made to the pond in February 2015, when there was a record high tide. At its highest point, the tidal waters reached (NS 8995092144) some 200 metres upstream from the ordinary spring tides level. Although the water level was substantially higher than normal and drowned many of the riverbank trees, it was still about a metre below the level of the sill of the input sluice gate. It was clear that a high tide was not the means of getting water into the pond. In order to get water in the river Black Devon to flow through the input sluice to reach the overflow lip, the level in the river would have had to have been raised by about one and a half metres.

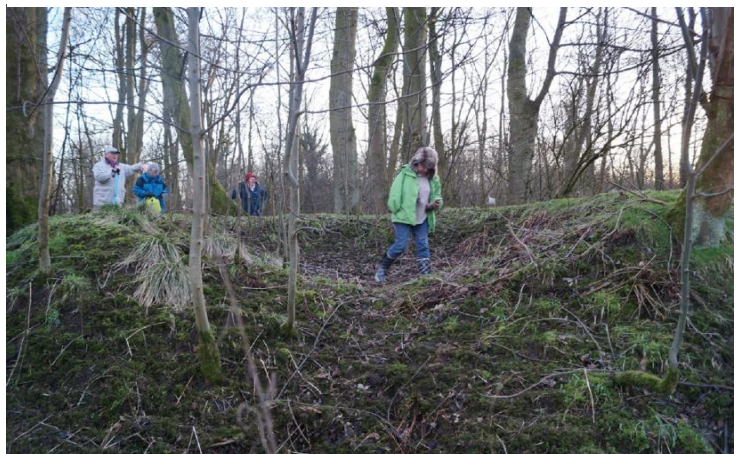
Figure 14. Remains of ice house.

The site of the icehouse was located on the edge of the pond (NS8972392074). The remains consisted of an earthen bank some 12 metres in external diameter and about a metre in height and had a lower part on the eastern side (opposite the bank of the pond). The bank surrounded a debris-filled hollow about a metre in depth.

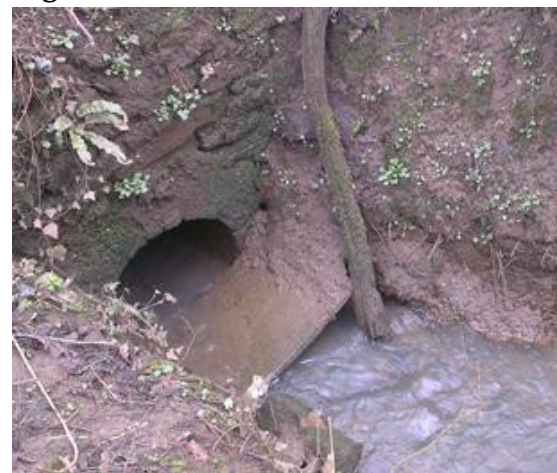
Figure 16. Drain volume increased.

The increased depth of water in the pond had led to an increased pressure at the outlet at the base of the dam and the flow of water through the outlet channel was greatly increased. It appeared that there was some mechanism which controlled the flow of water out of the dam and that it was partly open or leaking.

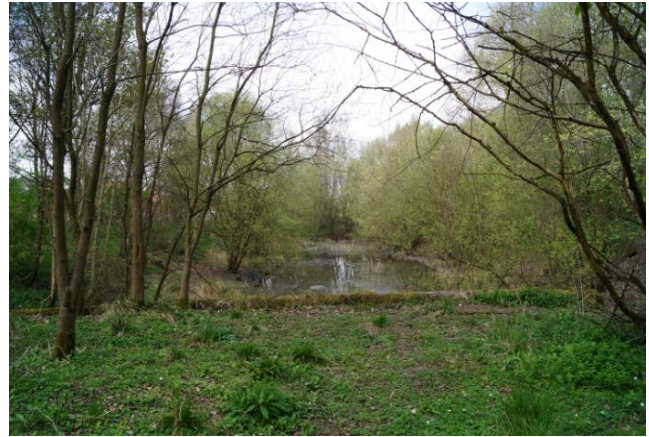
Figure 18. Earthen apron and dam.

Alloa Pond is located within an ox-bow lake, a natural, horse-shoe shaped depression, formed when the river Black Devon changed its course. The downstream end of the feature has been filled in and levelled off, creating a large, level apron across the end of the hollow. This feature forms an earthen dam across the south end of the ox-bow lake, allowing the level of the water to be raised.

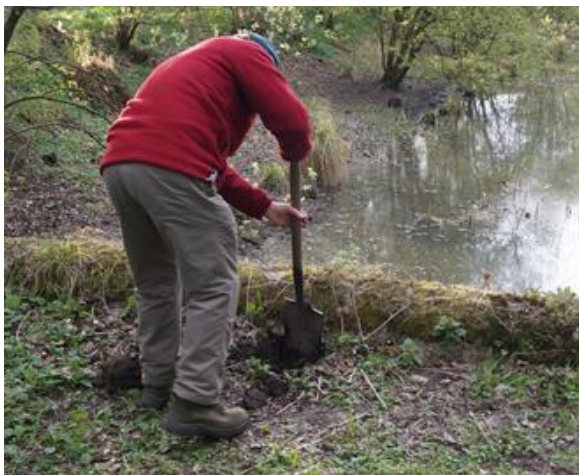
Figure 22. Test pit behind the facing wall.

A small test pit was dug behind the stone facing wall of the dam. This revealed that the wall is composed of two layers of sandstone blocks. While the facing is composed of well finished ashlar blocks, the rear portion is made of rougher blocks and ends about 30 centimetres below the surface of the apron.

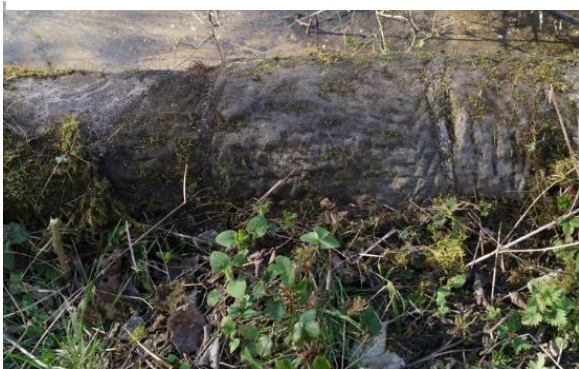
Figure 24. Rough coping stones.

There is a line of rough sandstone coping stones set on on top of the facing wall. These stones have similar mason's cut marks to the facing ashlar blocks.

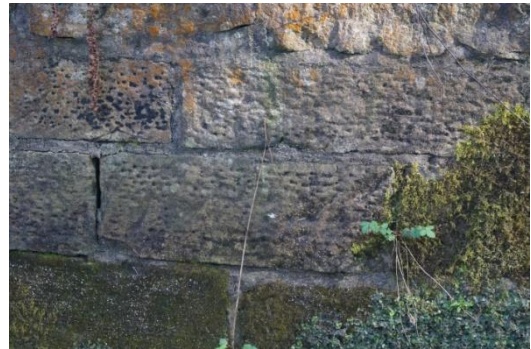
Figure 21. Well cut ashlar blocks.

There were several different types of joint mortar, suggesting that the wall had been repaired on a number of occasions. An overflow has been built into the southern end.

The facing wall is made of well finished sandstone ashlar blocks, laid in distinct courses. The blocks have been set in a lime and sand mortar and joints on the pond side have been filled with a cement-like mortar.

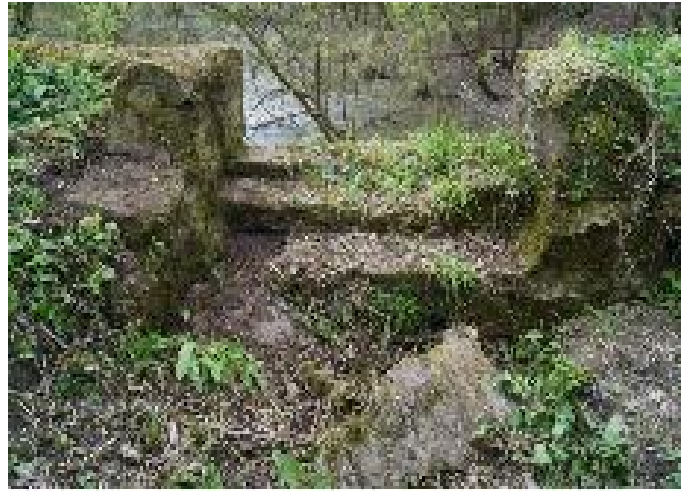
Figure 27. Overflow in the dam.

An overflow channel has been built into the wall of the dam to ensure a controlled level of water in the pond behind the dam. There are two short supporting walls on either side of the channel, with three sandstone steps leading down from the pond into the drainage ditch. At one time there has been a short, concrete run-off slipway running off the bottom sandstone step.

The overflow shows signs of repair with several different types of cement-based mortar used. The concrete slipway has been broken in half and here are signs of water having removed earth from underneath and around it.

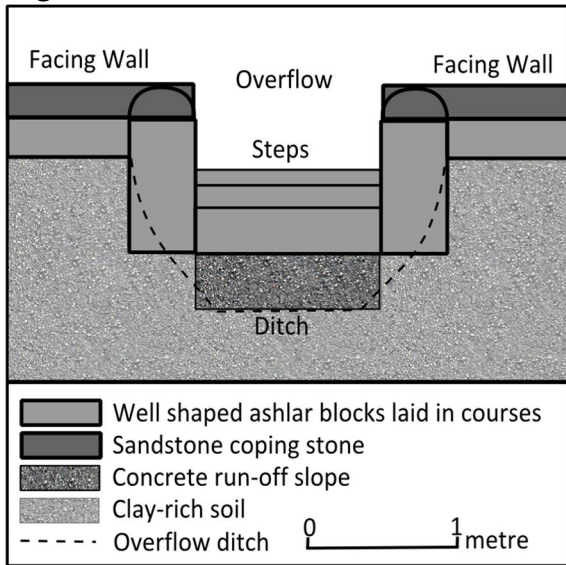
Figure 30. Overflow front elevation.

The overflow leads into a ditch cut into the earthen apron in front of the dam and leads to the North bank of the river Black Devon. The ditch has been filled in in two places to allow the path around the pond and the path along the bank of the river Black Devon to cross it and now cannot act as a drainage channel for the overflow.

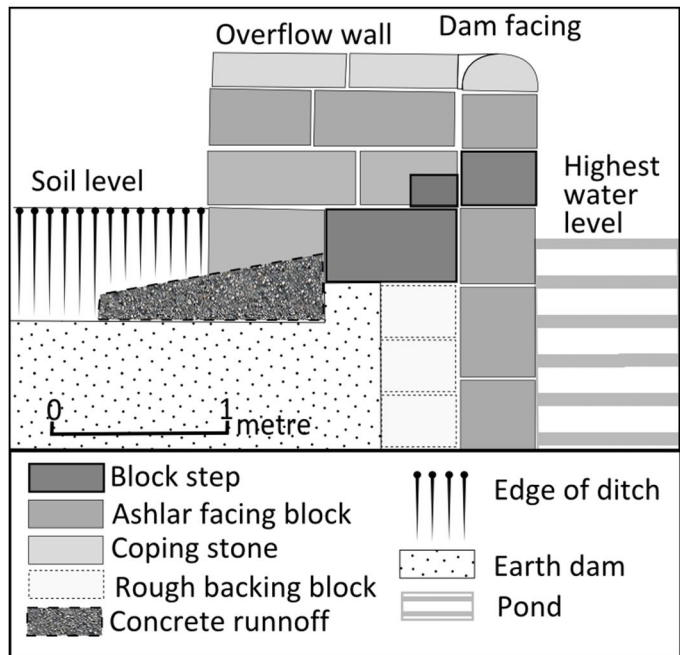
Figure 31. Overflow side elevation.

The level of the top step of the overflow has been surveyed with respect to the lip of the base of the inlet sluice. The top step sits some 40 centimetres above the level of the base of the inlet sluice.

If the lip of the weir in the river Black Devon was constructed some 50 cms above the level of the base of the inlet sluice, then some 10 cms of water would flow continuously through the overflow, maintaining a fresh supply of water in the pond.

Instead, the inlet ditch has now effectively become the pond drain.

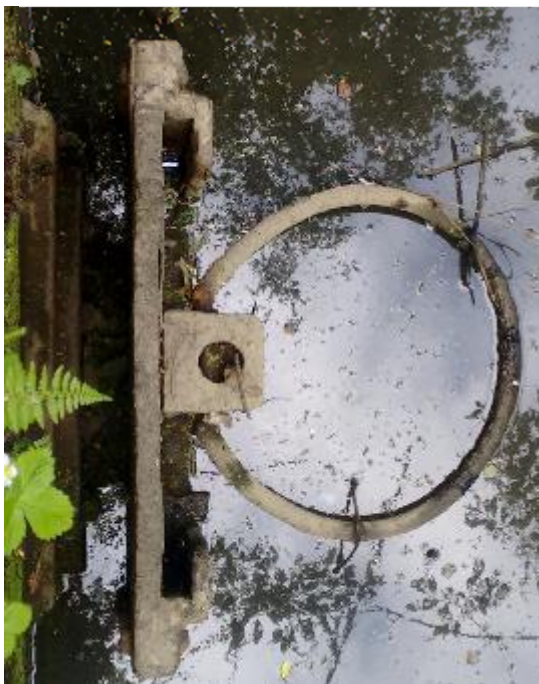
Figure 33. The sluice from above.

The sluice mechanism lies two metres North West of the overflow. Low water in the dam during the late spring of 2017 revealed the detail of most of the sluice mechanism. This took the form of a vertical plate, attached to a metal pipe leading into the facing wall of the dam.

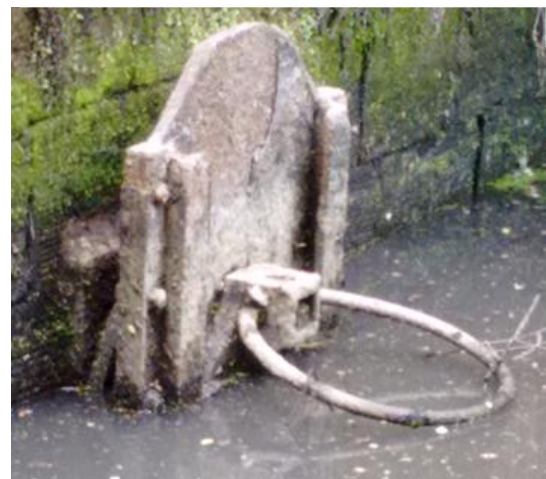
Figure 34. Front of the sluice.

Figure 34 shows that the metal plate has two very substantial side slides bolted on and there is a metal plate with a large, hinged metal ring sitting in the slot between these slides. This type of sluice valve is very common. The main inlet tower and the tower on the settling pond at Gartmorn Dam both have similar sluice valves controlling the outflow of water. The great advantage of this type of valve is its simplicity of construction and the fact that it has no or very few moving parts below water.

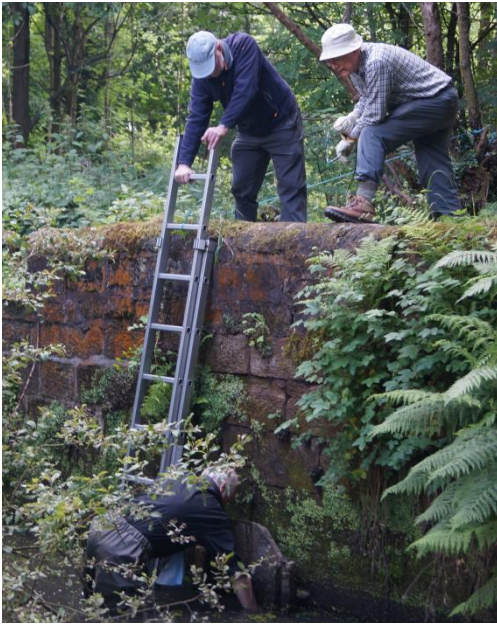
Figure 35. Underwater survey.

Unfortunately, the level of water in the pond did not drop far enough to show all the details of the bottom of the sluice valve mechanism. In addition, water coming in from the new drainage ditches is very murky.

Frustrated by the level of water never falling far enough to reveal the full extent of the sluice valve, an underwater fingertip study was undertaken. As part of the health and safety provisions for the survey, light weight plastic gloves were used as the water quality was poor. These prevented cuts, but allowed a sensitive exploration of the sluice mechanism.

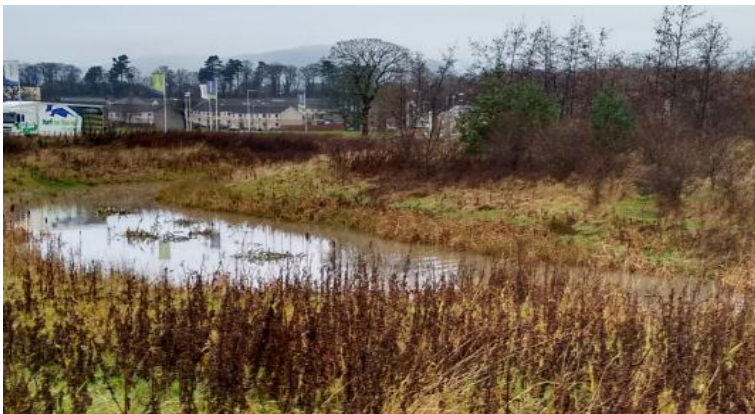
Heavy rain causes the pond to fill up and flood back into the new ditches and the inlet ditch.

Figure 125. New North drainage ditch flooded

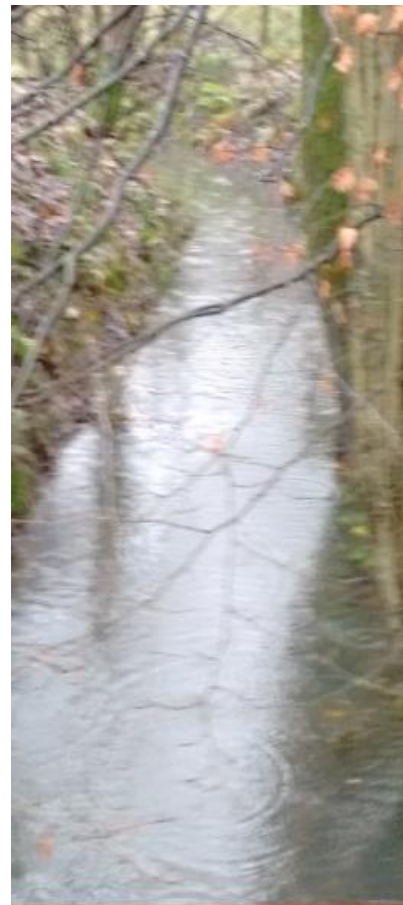
Figure 126. Inlet Ditch flooded.

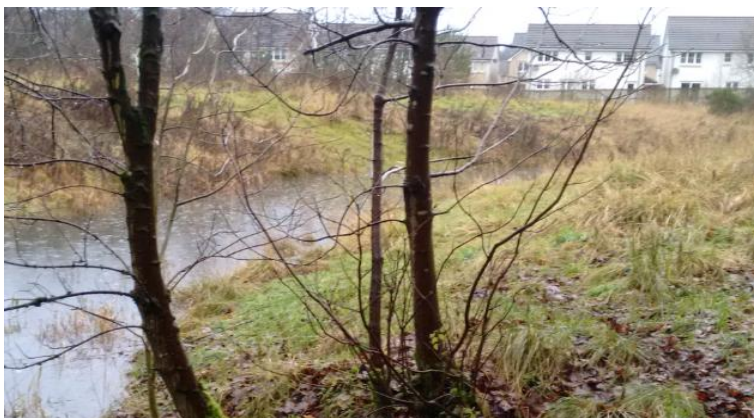
Figure 127. New East drainage ditch flooded

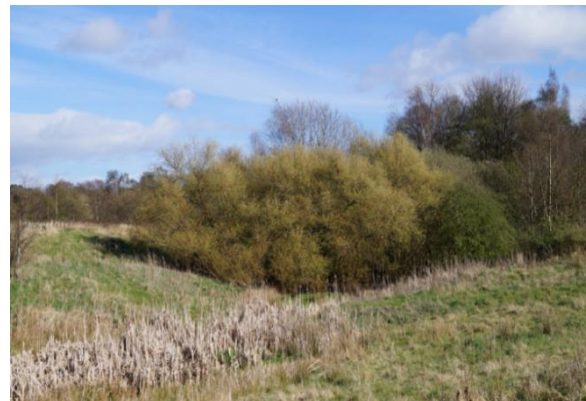
The pathway has been bridged over the inlet ditch at some point in the past. Sadly, two large sections of the path have been removed in the construction of the modern drainage ditches.

Figure 134. Path lost to north ditch.

However, the water is not treated, raising concerns about pollution and the pond silting up. In addition, the new ditches have severed the 19th century formal paths.

Perhaps it would be possible to restore the line of the path using large pipes and backfilling, as was done in the past to retain the pathway over the inlet ditch.

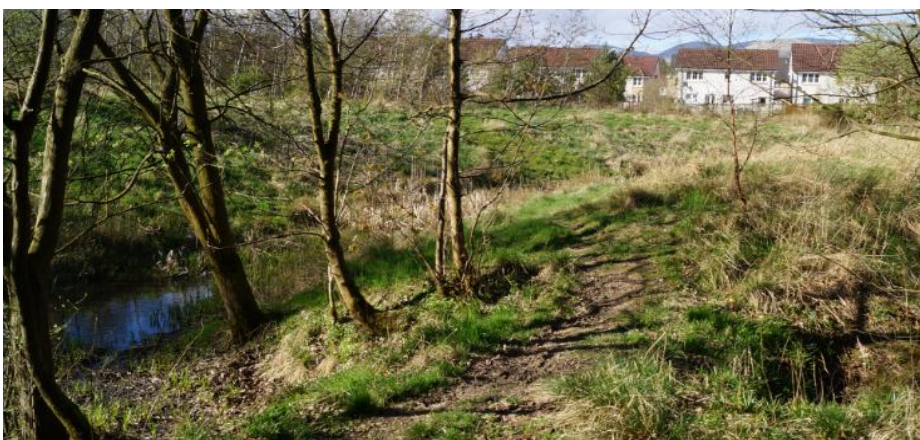
Figure 135. Path lost to east drainage ditch.

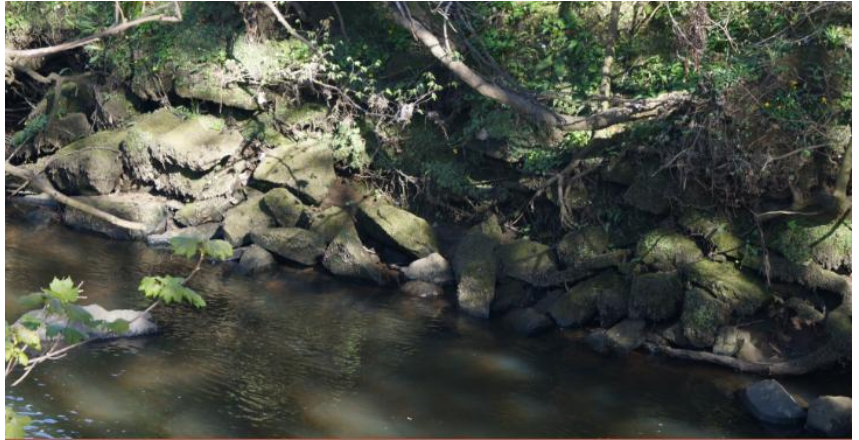
Both banks of the river Black Devon have been protected by walling for a considerable period of time. Most of the walling is composed of rough sandstone blocks. Some of the stone walling is in very poor condition and in some places has been lost entirely.

Figure 136. Walling on the east bank of the Black

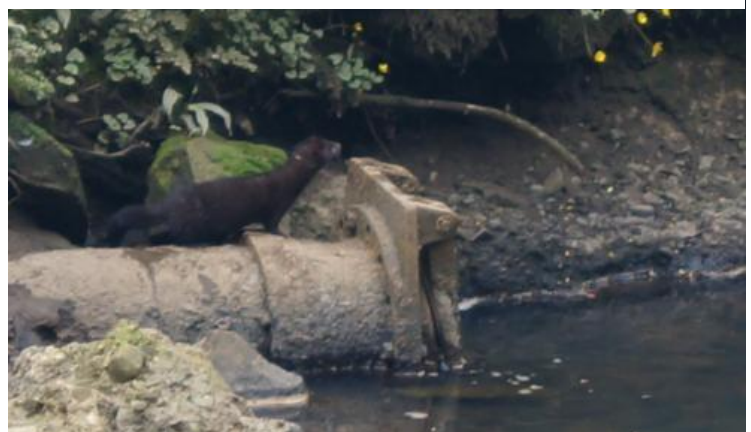
A small section of the east bank has been protected with a roughly cast concrete wall. This wall repair appears to be associated with the numerous field drains which are used to keep the fields on the east bank which are close to the upper tidal limit free of water.

Figure 138. Concrete wall, field drain and mink.

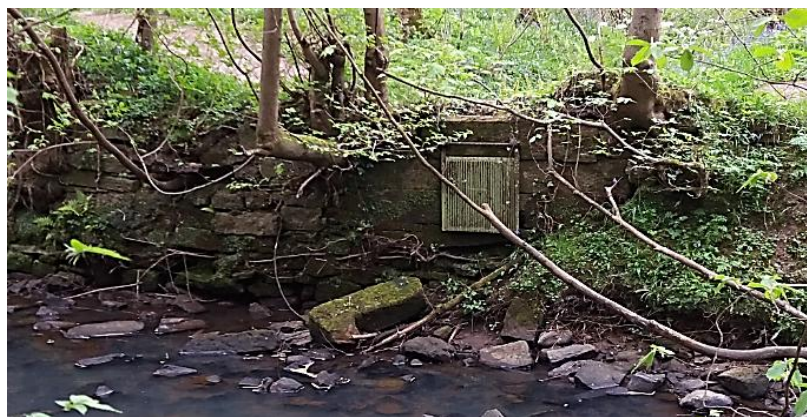
On the west side of the river there is a matching area of stonework. It is built of roughly squared sandstone blocks and has a clearly formed straight end on the downstream end. The input sluice is built into this structure. It is likely that these two structures relate to the vista and bridge shown in the 1710 plan of the Alloa Estate. (36)

Figure 141. Inlet sluice built into older structure.
