Clackmannanshire
Field Studies Society

Linn Mill

Excavation and Survey Report, 1974

Second Edition, 1979

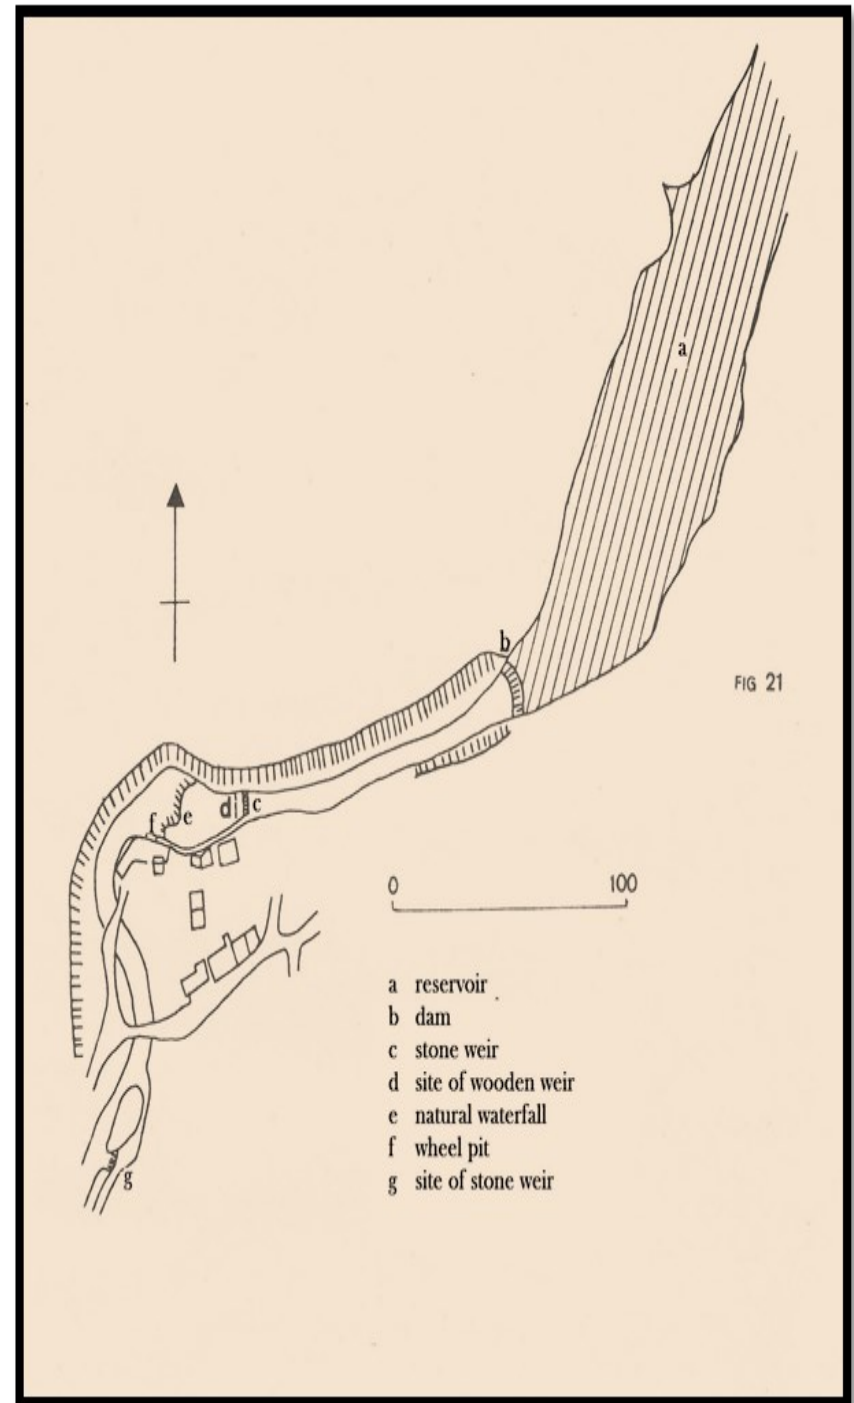
The potential of the site for water power lies in the existence of a large waterfall (point e) which provides a natural head of water approximately four and one half metres in height. By constructing the mill (point f) below the waterfall a more than adequate head of water can be obtained by the use of a very low weir.

A row of postholes cut into the bedrock just below the stone-built weir. The stone built weir (point c) offers no greater head of water. Rather it represents a move towards a greater degree of permanence in the structure. The reservoir (point a) held behind the stone built dam (point b) is of unknown date. It most probably indicates the problem of a low level of water during the summer months. A problem which must have been intensified by the considerable quantities of water being removed by the lade at Forestmill to supply the Gartmorn complex.

It is interesting to note that another lade complex; the feeder system for the water powered colliery pumping engine at the Craigrie Pit, started from this site (point g).

Stage 11 – (See figs. 1 and 6).

The building marked 11 on fig. 1 was partially excavated before the rock fall and the subsequent flooding destroyed it. The foundations were made of rough blocks of yellow sandstone except for the corners which were ashlar blocks. The squared off W. section contained the bases of two ruined hearths. These were cleaned out and were found to contain fire bricks and clay base tiles from a grain drying kiln. This suggests that building 11 was a grain mill with an attached kiln. The type of tiles are characteristic of the period 1790 – 1810 (3) and it is known that a corn mill was in operation here at that date (4)

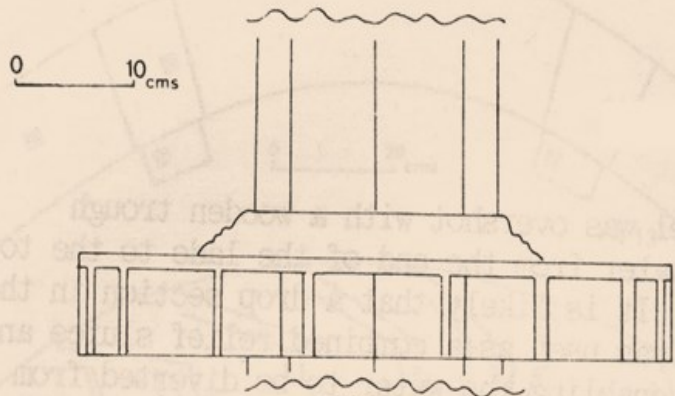
Fig 18

NAVE - The iron nave bolted together to fit over the octagonal shaft (See figs.18, 19, 20.).The ends of the arm fitted into slots, were covered by fitted wrought iron plates and bolted in place. The two halves of the nave were bolted together by means of wrought iron straps. (FIG. 19 shows the inner surface of one half of the nave).

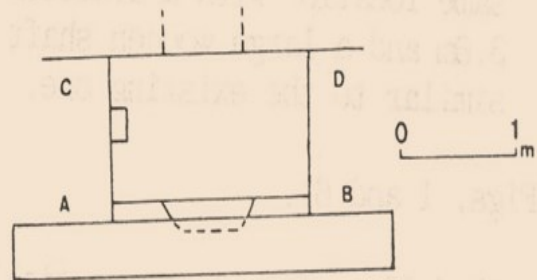
FIG 4

(See fig. 4) There is a cut stone bearer in the inner wall of the pit & 5a)wheel pit. The basal surface of the old main bearing lay 0.6m below that of the new. This coincides with the centre level of the lower shaft hole. This stone bearer is underlain by cut blocks and overlain with rubble fill.

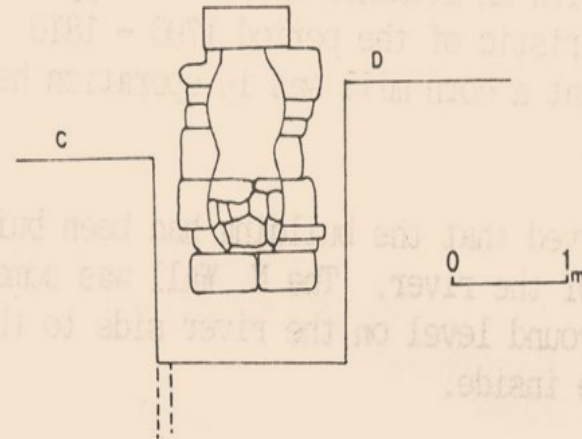
FIG 5b

c. **Shaft hole** There are two shaft holes in the wall of the mill. **See (fig. 5b)** The centre of the lower shaft is 0.6m below that of the upper. The lower hole is partially blocked with stones and bricks. The two shaft holes are of identical size.

(This suggests that the earlier shaft was a large wooden beam similar in design to the existing one)
